## **Simcoe Manor and Village**

Location: Beeton, Ontario

### **Feasibility Study - Structural**

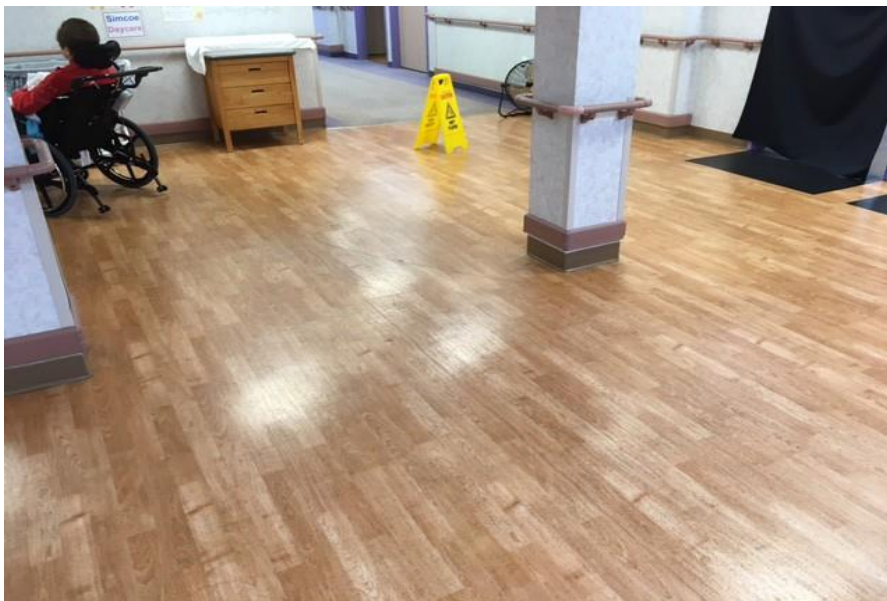
Photo #1

The original building from the break of the century is the south west portion of the development. The original building was in 1991 “wrapped around” with a new one and two storey addition. The 1900 building was a two storey structure with crawl space. The floors and roof are framed using wood joists and wood decking supported on masonry exterior and corridor walls. The wood floors are uneven; they sagged and deflected during the time due to various use, loadings and moisture content they were exposed to. At the time of 1991 addition some areas of the existing floors were reinforced and levelled using light weight leveler material. Some floors in this oldest wing are still uneven causing problems navigating the wheelchairs and getting from one area to another. See Photo #1.

The wood framed floors of the original 1900 building and the slab on grade of the 1991 addition settled and moved differently creating imperfections and small steps between some floor areas. The Simcoe Manor informed us that these small steps making movement difficult for residents were fixed at times using small concrete sloped ramps/transitions.

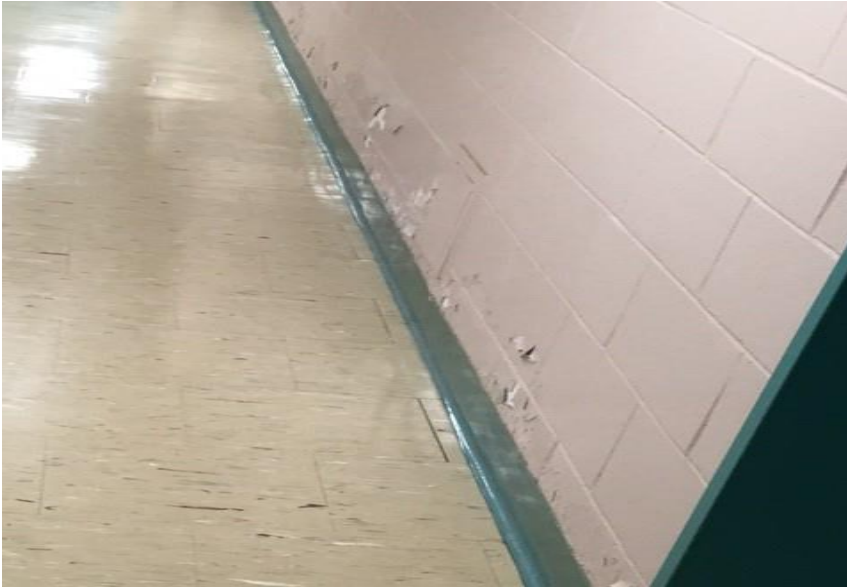
The 60's building appears to have some structural problems related to very high ground water level. Based on the sump pump located in the basement of the building the normal ground water level is only about 1 meter below the basement floor level. Due to the seasonal fluctuation the ground water level is sometimes just below floor level bringing moisture into the premises.

The interior corridor walls show signs of water penetration and dampness. Peeling paint and wall deterioration could be observed throughout the length of the corridor walls.  
See Photo #2

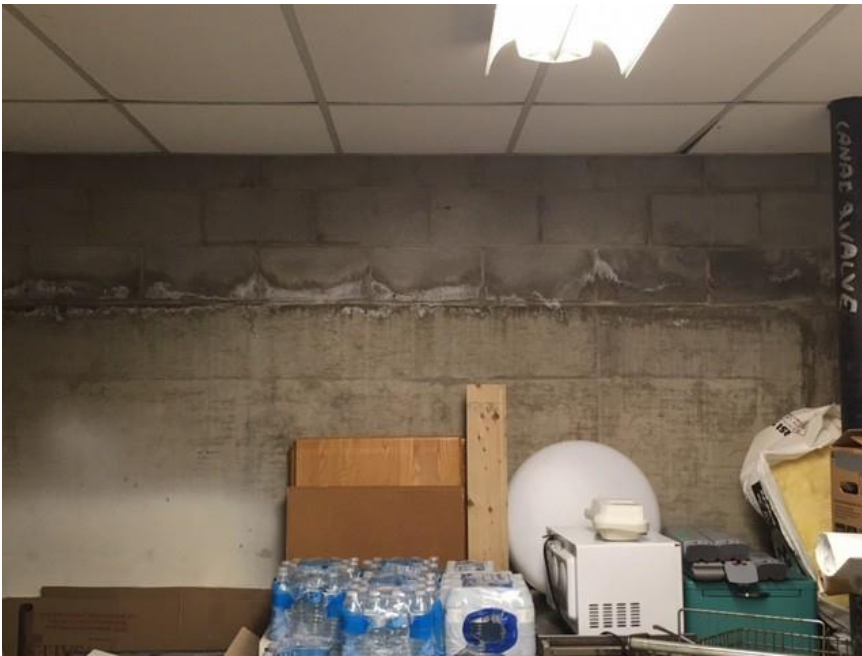
Photo #3

At the north side of the 60's building the paved parking area is sloped in such a manner that water is directed to the face of the building. Water stains can be observed on the inside face of the north basement wall. We understand that during heavy rain when outside soil gets saturated there is lots of water leaking into the building and running on the face of the concrete foundation wall. Structurally there is also a concern that the existing concrete foundation wall is not carried to and laterally supported by the floor structure. With the large soil and water pressure from outside the foundation wall is stressed and could fail. See Photo #3.

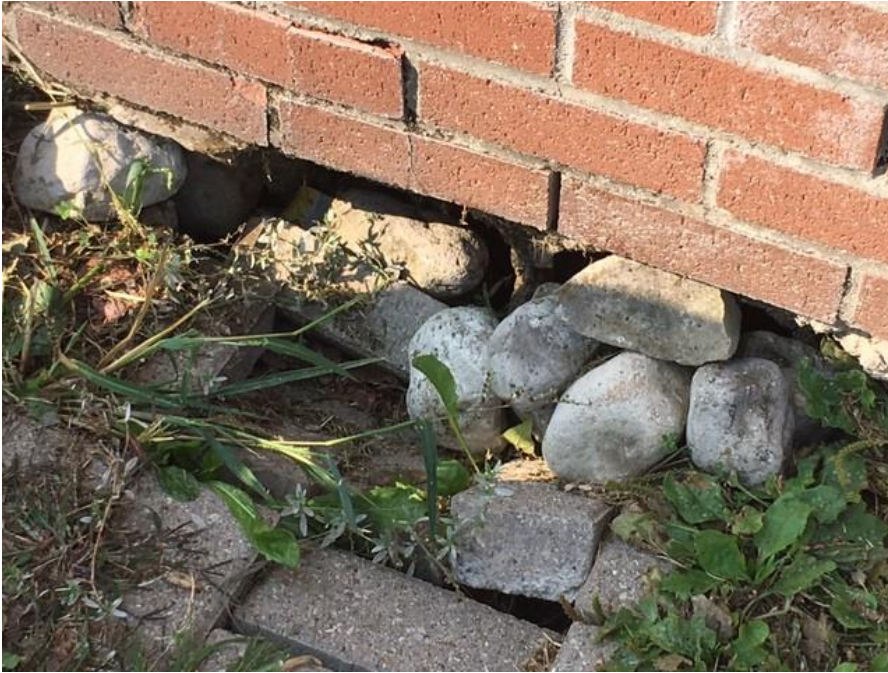
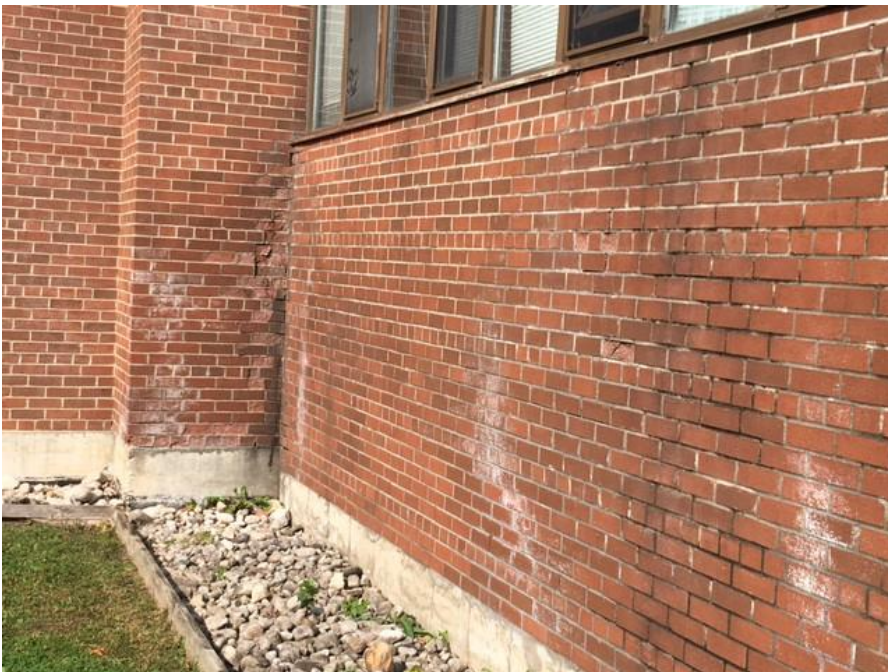
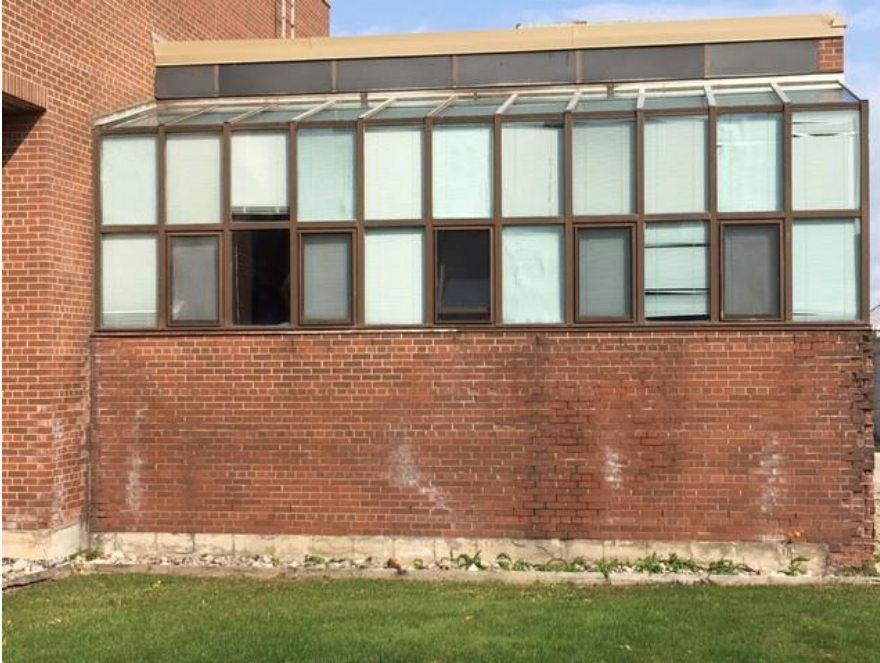
The north, south and east exterior walls of this 60's building are deteriorated. The damage is caused by water penetration and freezing/melting cycles. In some instances the top of foundation walls are deteriorated so much that there are holes and large gaps between foundation walls and veneer/wall above grade. See Photo#4, #5, #6

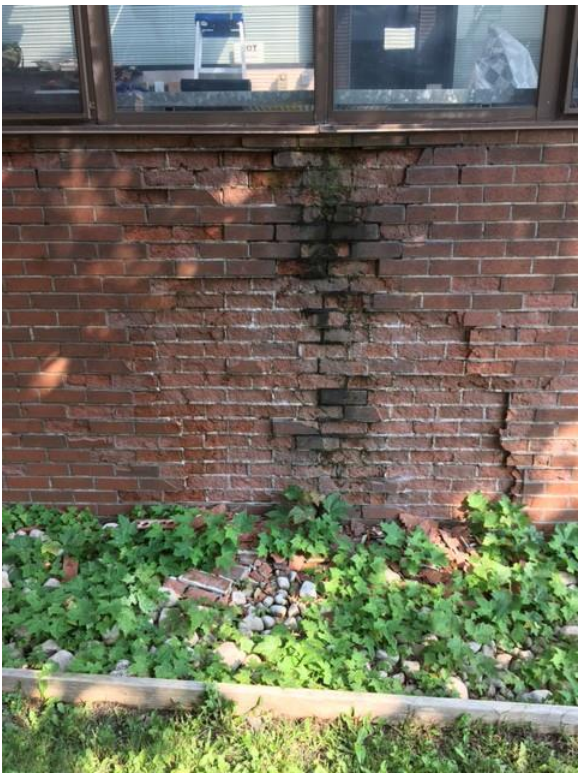
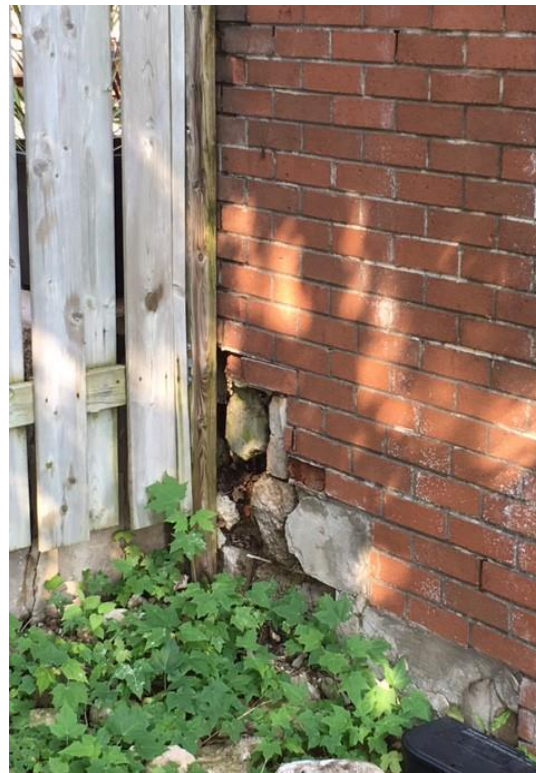
The exterior wall of the Solarium is deteriorated with water penetrating through the wall and the space inside can no longer be used by the residents. See Photo #7 and #8.

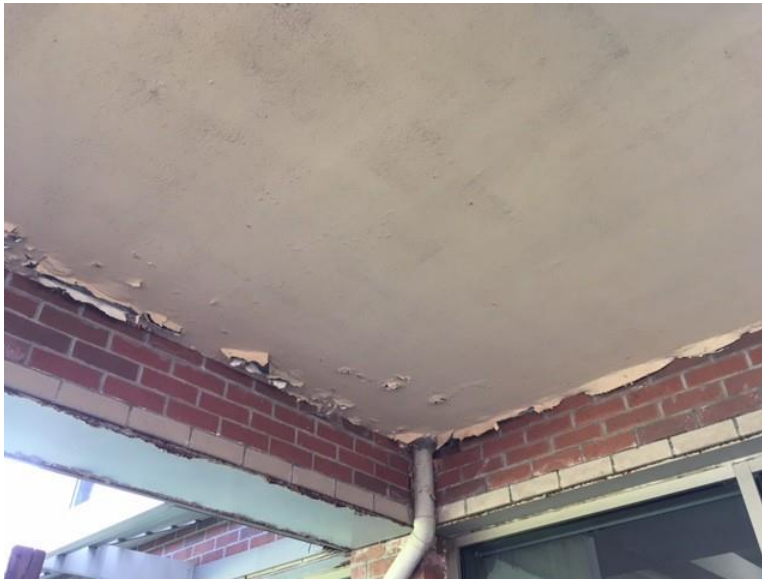
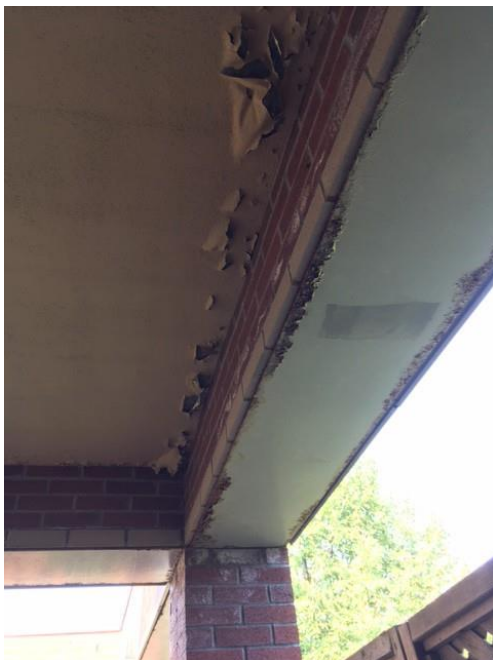
The exterior decks are constructed using precast concrete slabs supported on steel beams in two directions. It appears that the deck waterproofing failed, specifically around the deck perimeter close to the deck upturn parapets. This allows water to penetrate into and through the precast slabs. The water damage causing extensive paint peeling on the underside of concrete slab and steel beam rusting was observed on the soffit of these decks - typical throughout. See Photo #9 and #10.
