**PHASE TWO ENVIRONMENTAL SITE ASSESSMENT
PROPOSED SIMCOE COUNTY SERVICE CAMPUS
2 BORLAND STREET EAST
ORILLIA, ONTARIO**

THE CORPORATION OF THE COUNTY OF SIMCOE

PML Ref.: 20BF055
Report: 2
January 2021

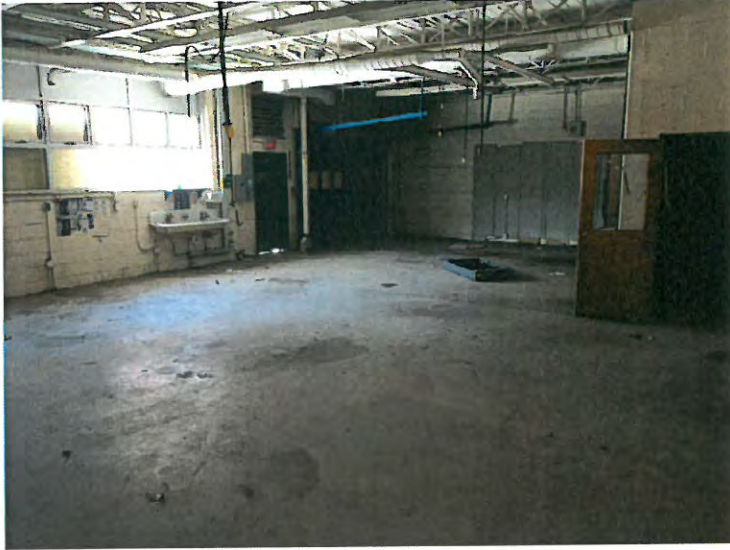
PHOTOGRAPH 3: Former auto shop classroom.

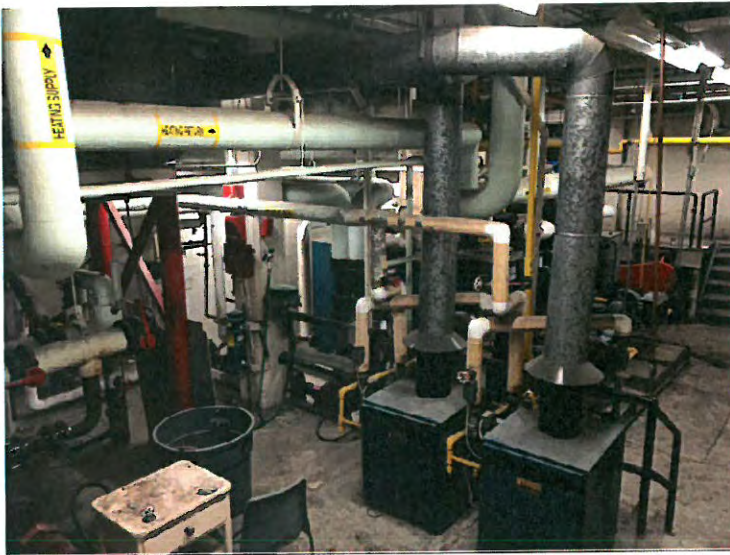
PHOTOGRAPH 4: Boiler room inside building.
