FUNCTIONAL SERVICING REPORT

South Shore Homes

June
18, 2020

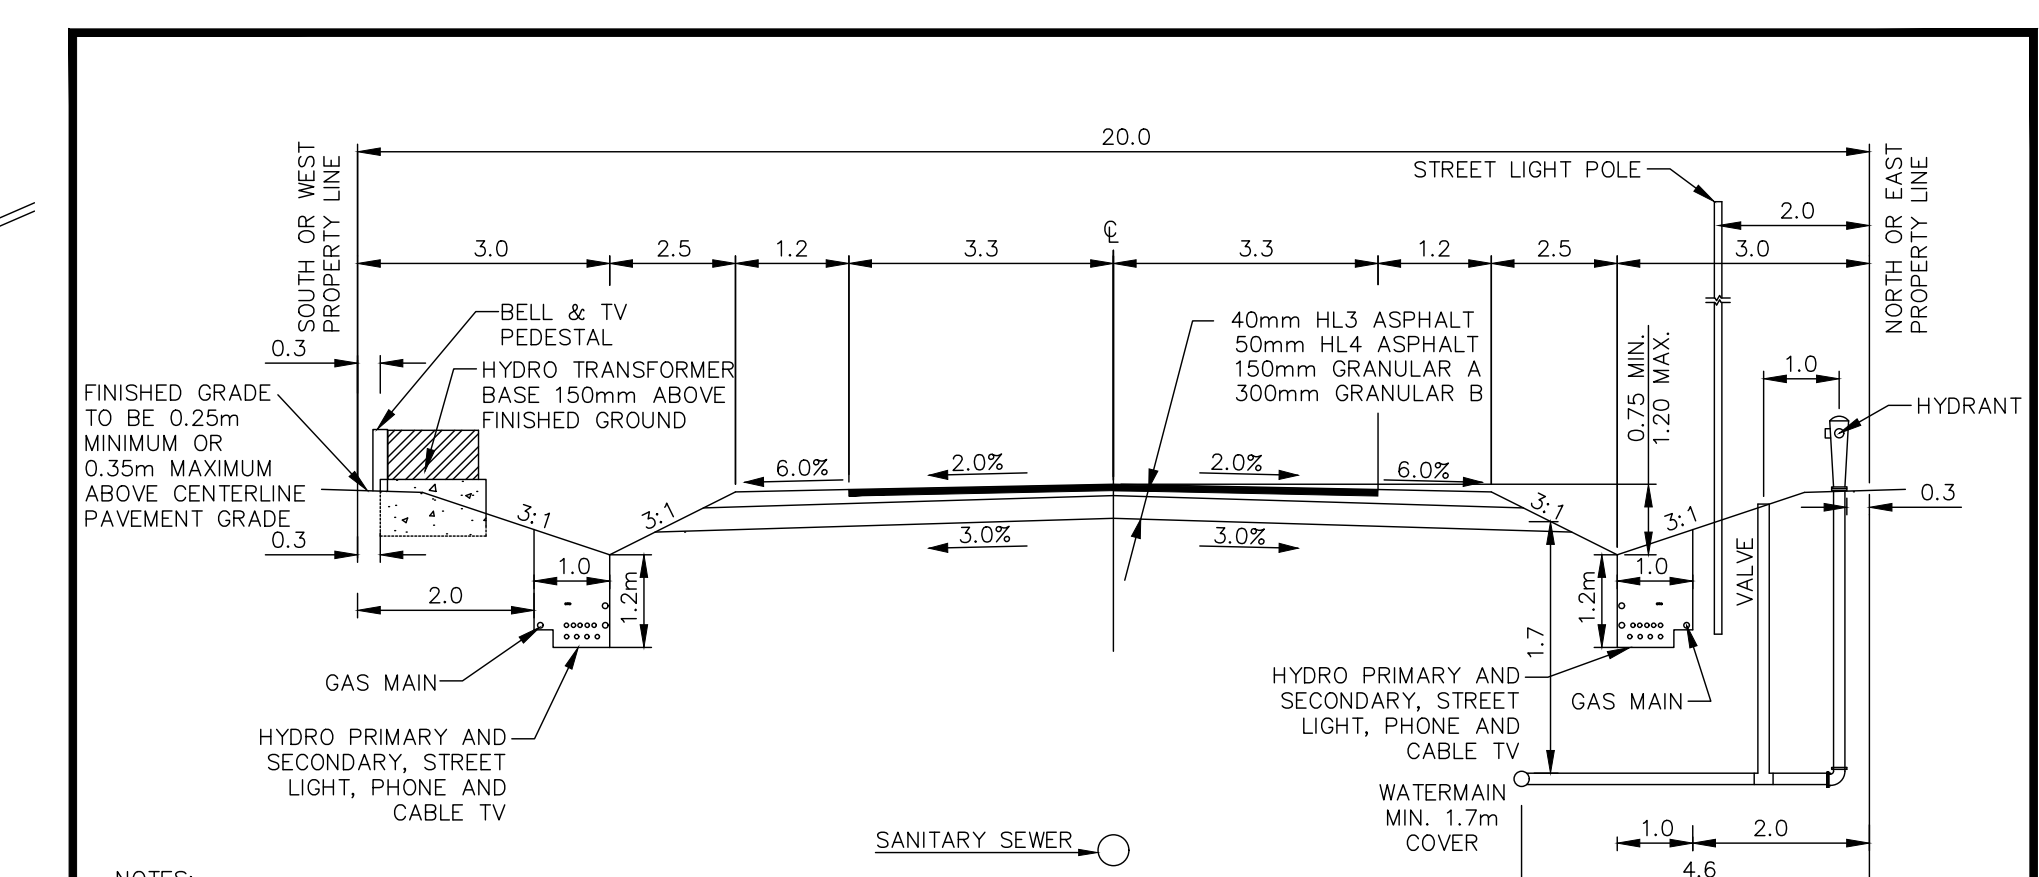
NO.	REVISION	APR'D	DATE	TOWNSHIP OF SEVERN	APR'D:	DATE: 2012
				SEMI-URBAN ROAD (OPEN DITCH)	DRAWN:	SCALE: NTS
				20.0m RIGHT OF WAY	STD. No.	201
				6.6m ASPHALT SURFACE

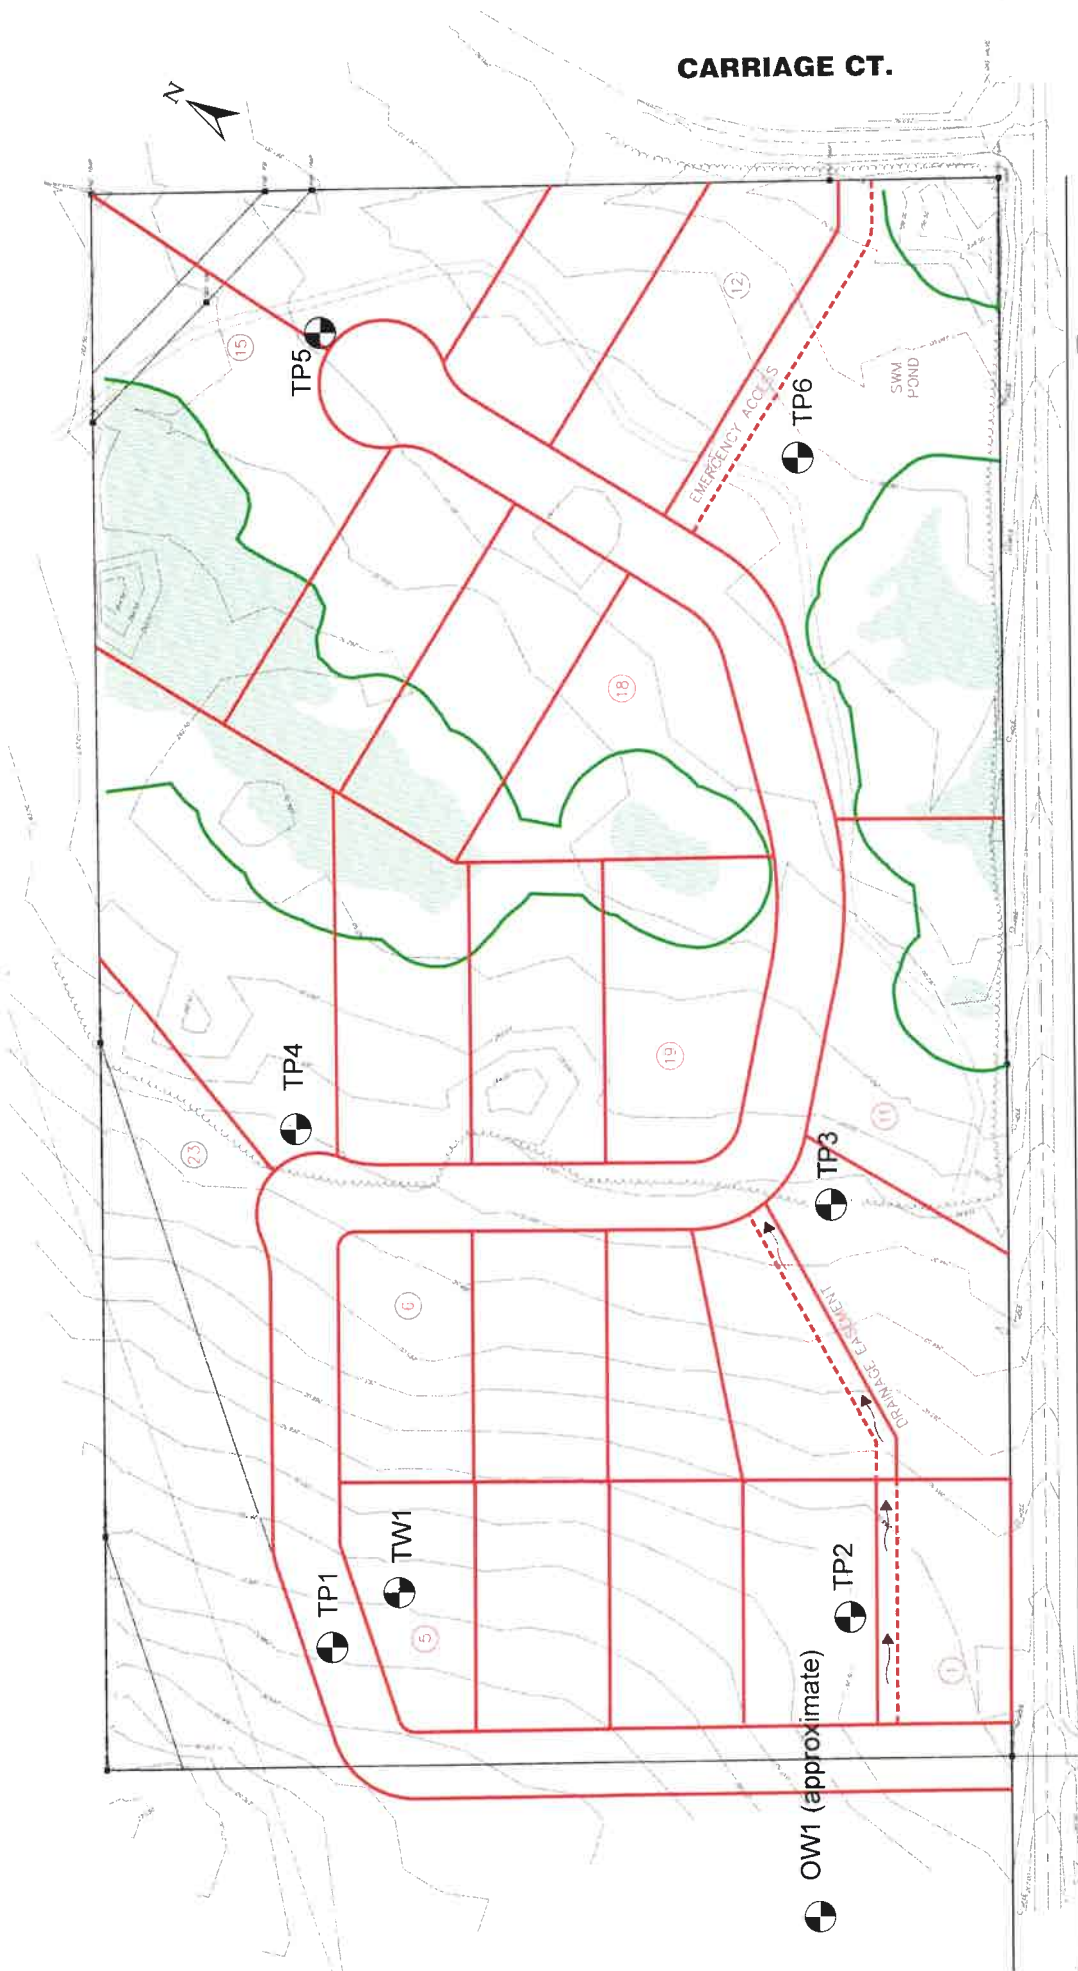
FIGURE 1

To characterize soil and shallow groundwater conditions, six exploratory test pits were completed using excavating equipment within accessible portions of the subject lands on August 22, 2019. The test pits were completed to depths of 1.67 to 2.13m below grade. The soil profiles were logged and representative soil samples were collected for classification and further analysis. Figure 1 shows the approximate test pit locations.

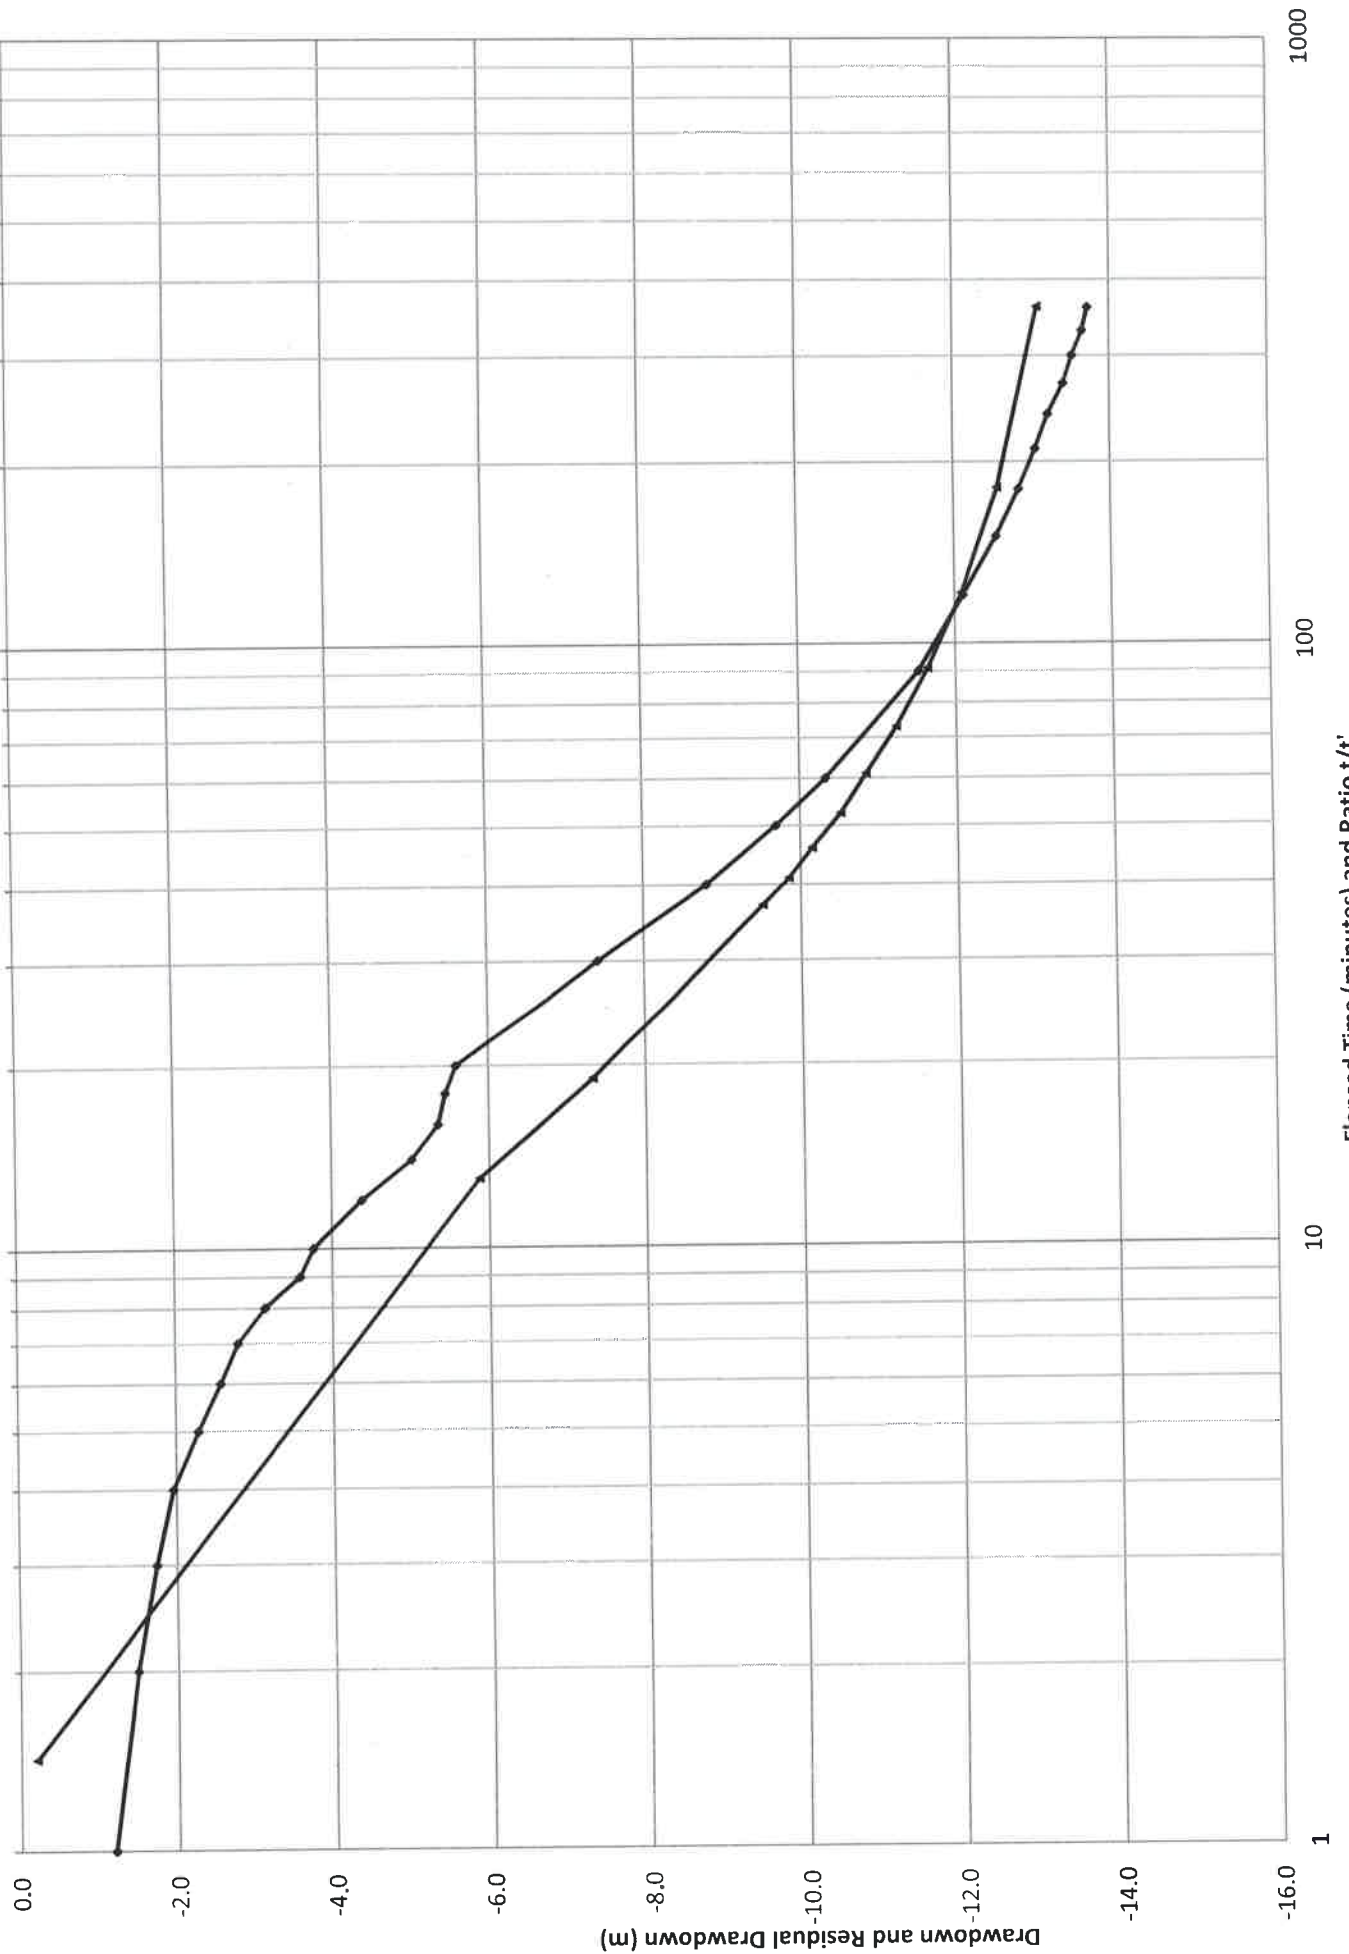
Figure 2

South Shore Caden Estates Inc. - TW1 Pumping Test

Test Well 1 was subjected to a 6 hour pumping test at a rate of 14 L/min on August 22, 2019, beginning at 11:30am. Water levels were observed in the test well on a regular basis during pumping and for an 848 minute period of recovery after pumping ceased. Water levels were also observed on a regular basis in nearby OW1, located about 200m southwest of TW1. Water levels were observed using an electronic water level meter. Pumping rates were controlled by an in-line valve and confirmed using a calibrated container. Water was discharged from the well about 20m to the south.

A total of about 5,040 litres of water were pumped from the well during the 6 hour pumping test. The Ontario Building Code recommends a design flow of 1,600L/day for a 3-bedroom home and 2,000L/day for a 4-bedroom home, and TW1 is more than capable of supplying these yields.

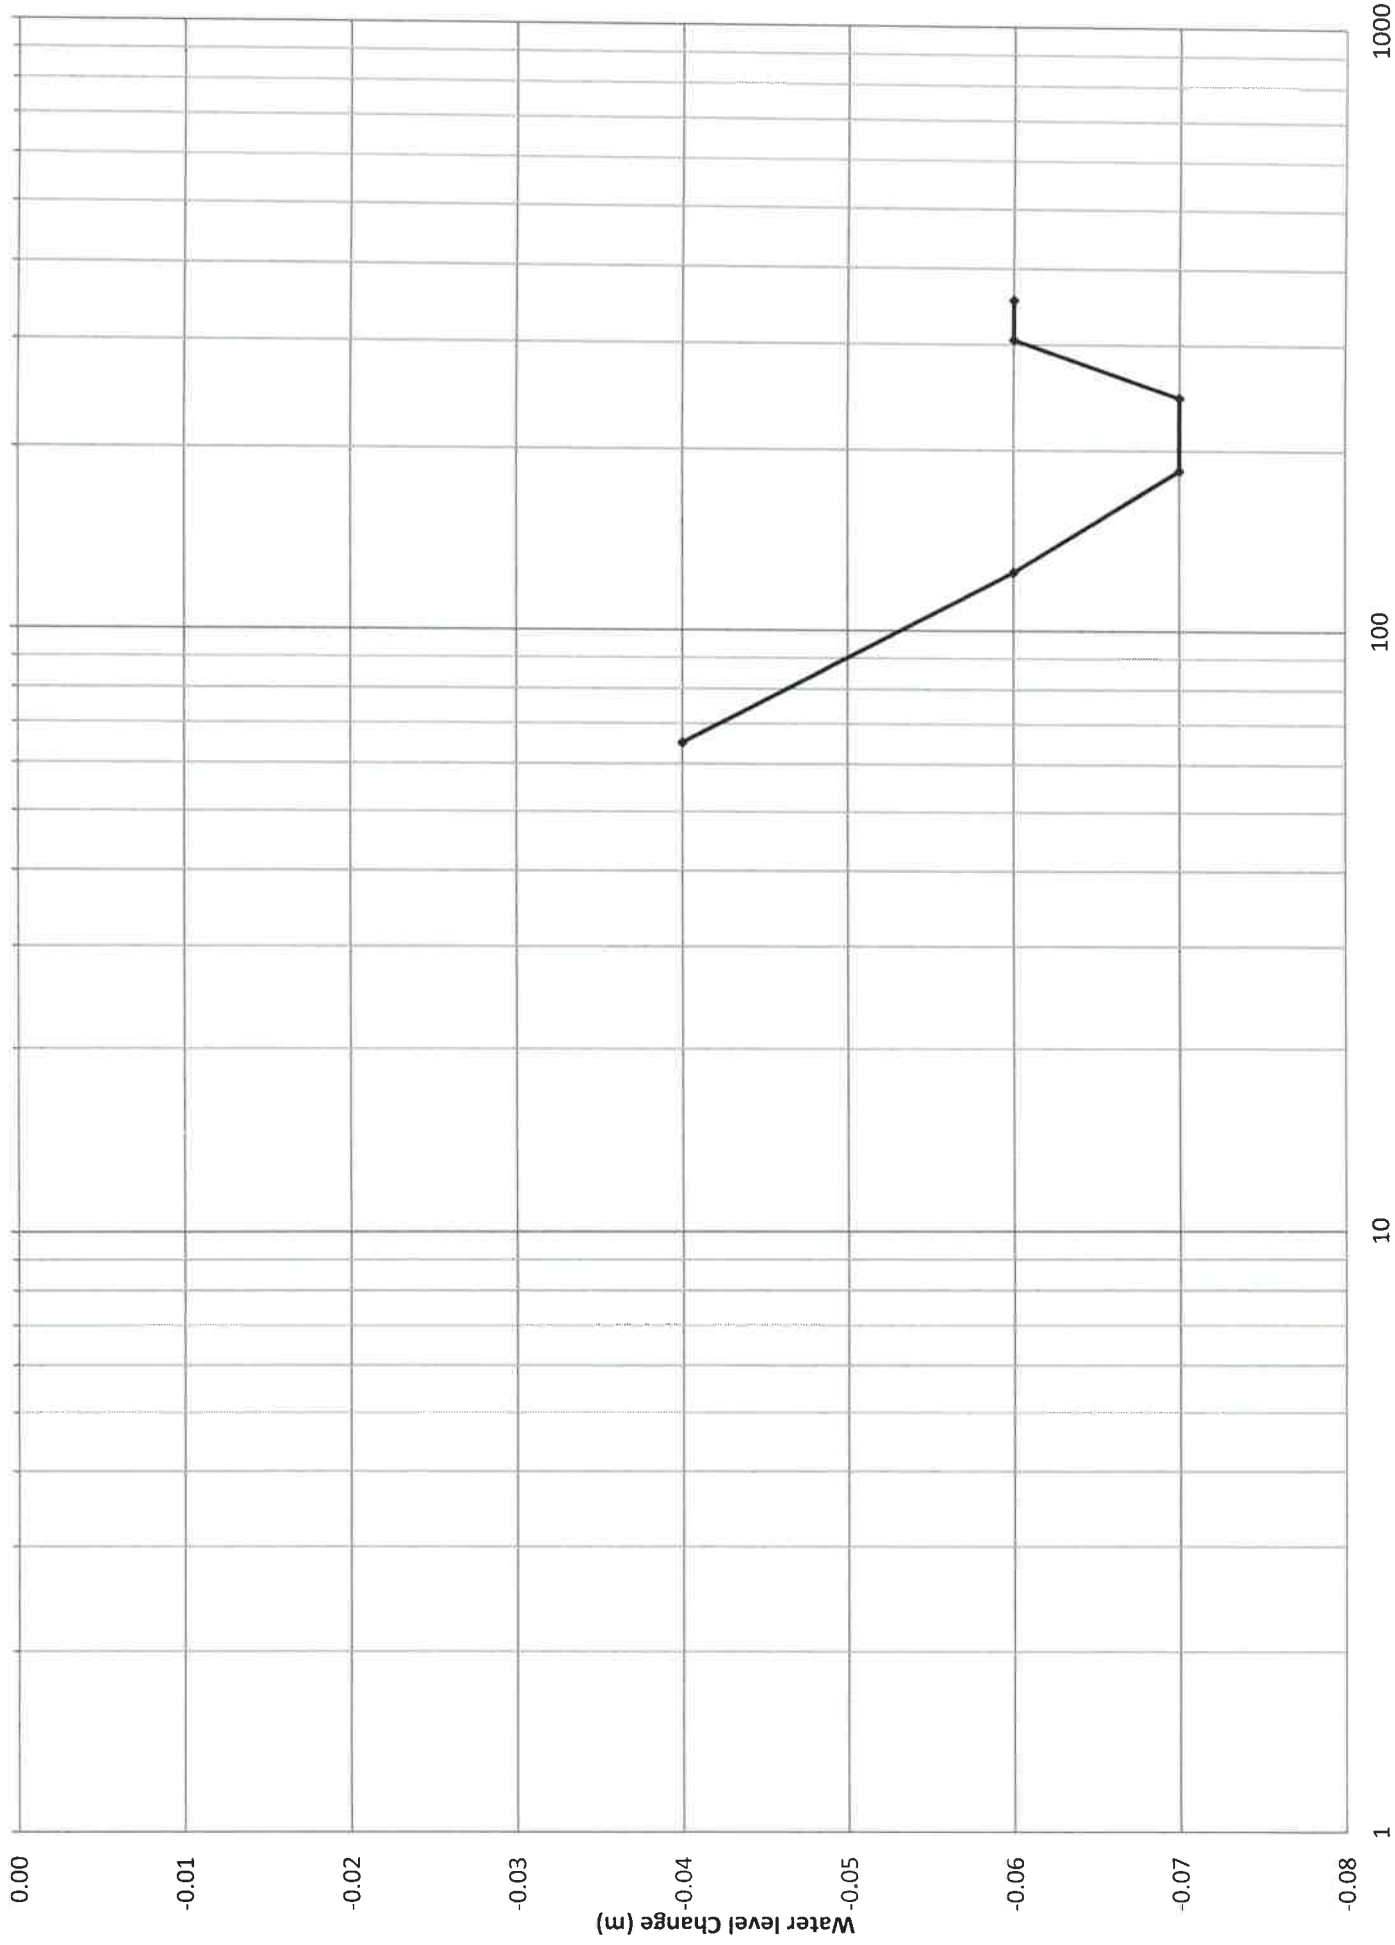
Figure 3

South Shore Caden Estates Inc. - OW1 Observations During TW1 Pumping Test

During the TW1 well testing program, water levels were observed on a regular basis in OW1 (MECP Well No. 57-7671), located approximately 200m southwest of TW1. OW1 is a 7.3m deep bored well, and is likely completed in the upper overburden aquifer, to a shallower depth than TW1. Attempts were made to obtain permission to observe other local wells completed in the same aquifer setting as TW1 (i.e. the intermediate-depth overburden aquifer), however only one other off-site well was made available for observation (due to other properties' access limitations, buried casings or inability to obtain observation permission) at 3978 Dunford Drive. This unrecorded drilled well was determined to have a static water level of 34m below grade and, based on other well record data in the vicinity, will be completed in the bedrock aquifer and was not observed as this well will be hydraulically isolated from TW1 by more than 40m of overburden deposits.

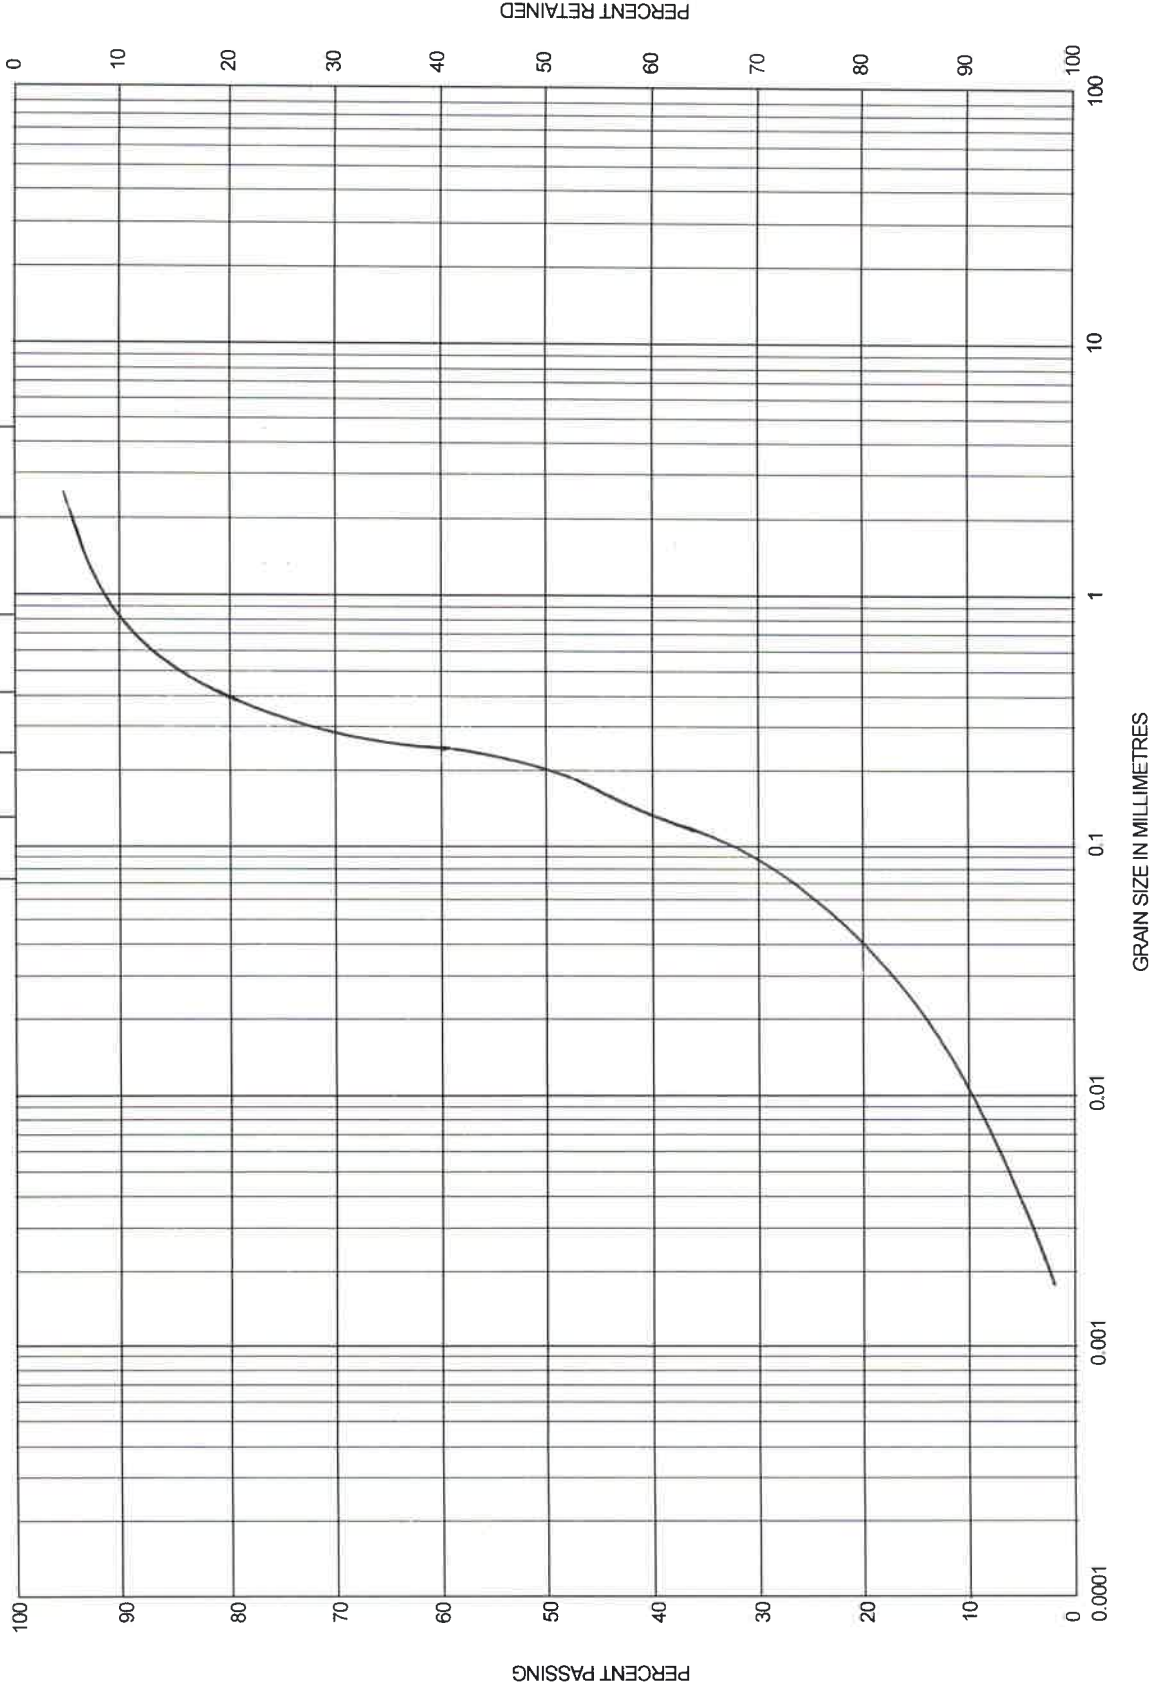
GRAIN SIZE DISTRIBUTION CHART

PROJECT / SAMPLE **South Shore Caden Estates Inc. - Test Pit 2, Sample 2**

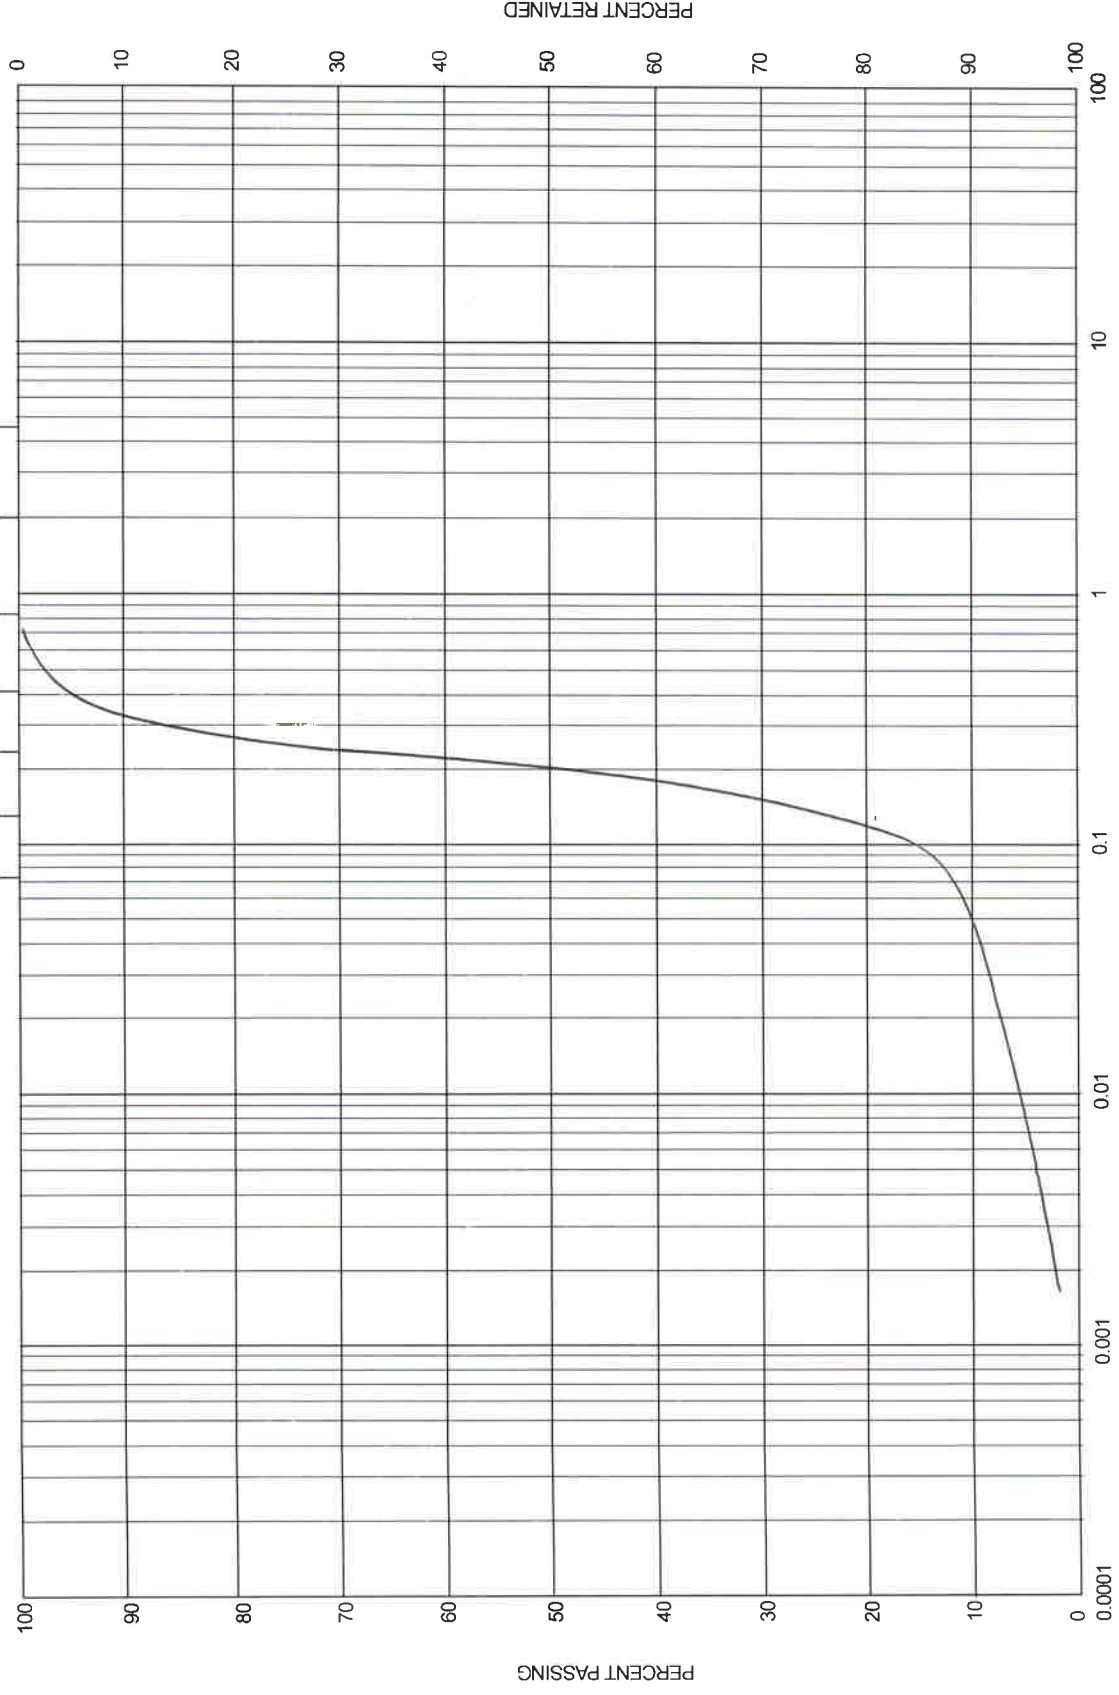
GRAIN SIZE DISTRIBUTION CHART

PROJECT / SAMPLE South Shore Caden Estates Inc. - Test Pit 4, Sample 4

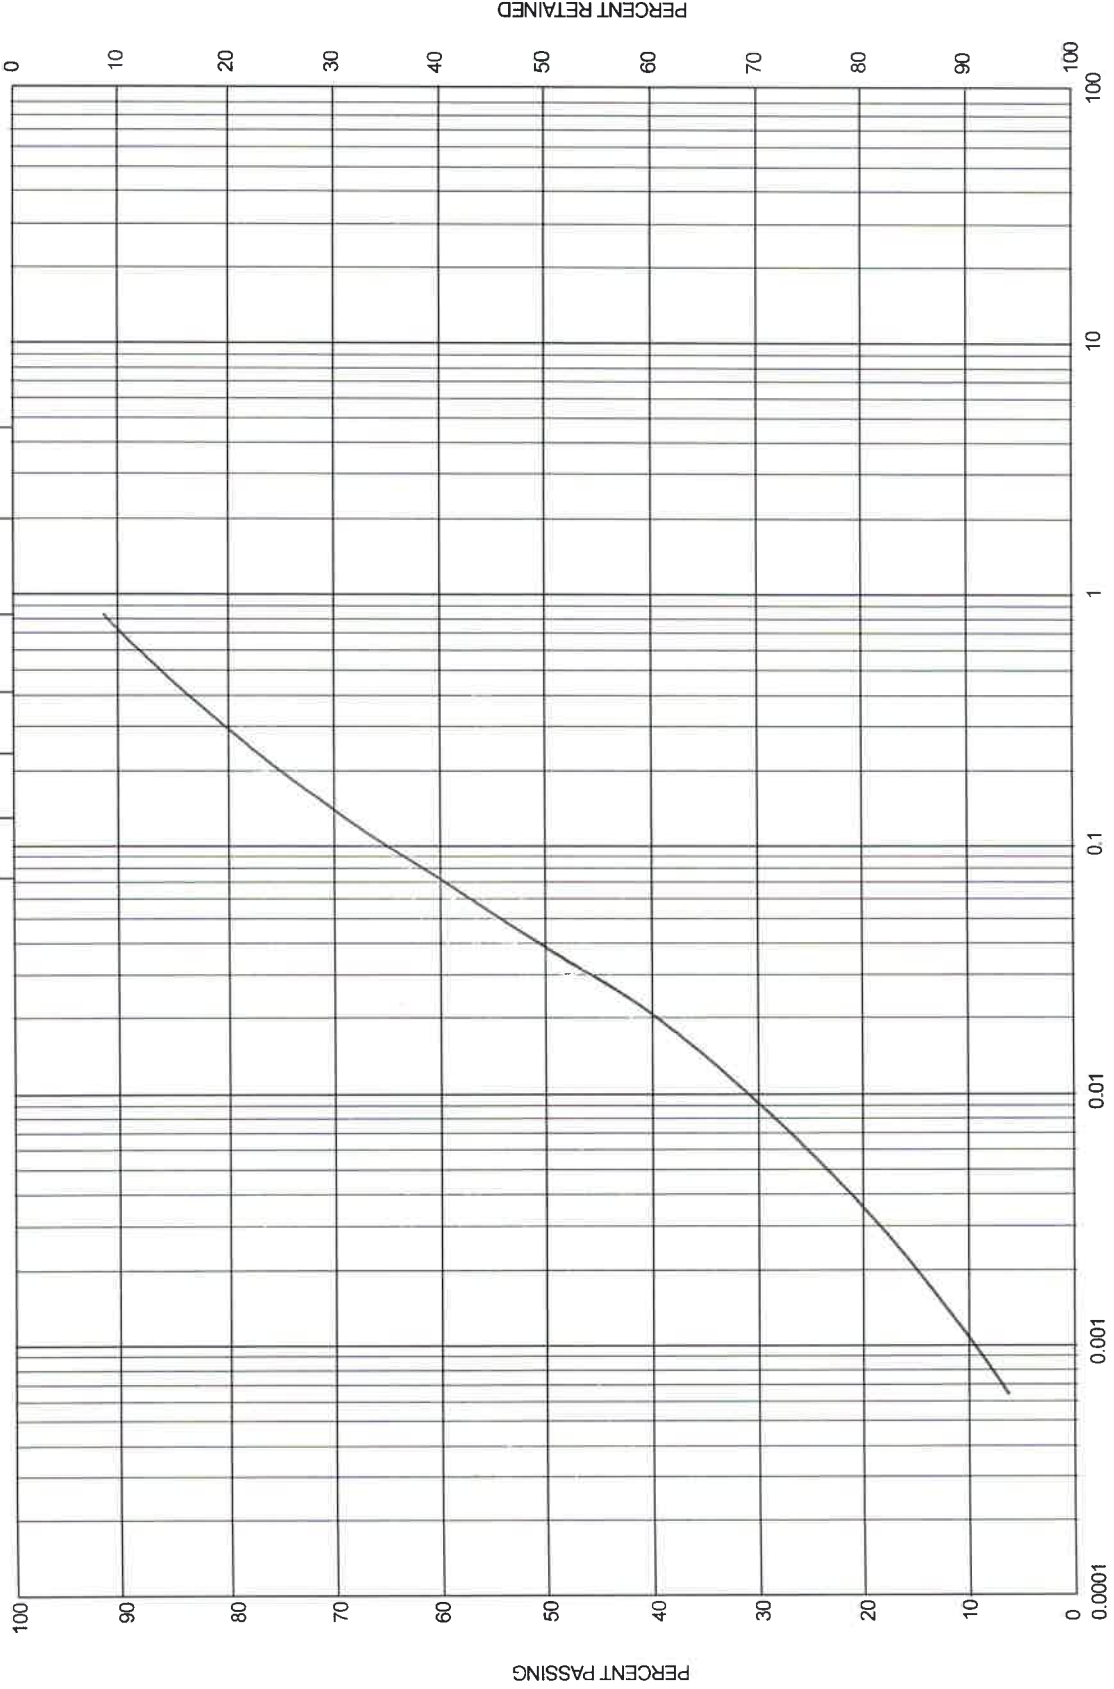
GRAIN SIZE DISTRIBUTION CHART

PROJECT / SAMPLE South Shore Caden Estates Inc. - Test Pit 6, Sample 5

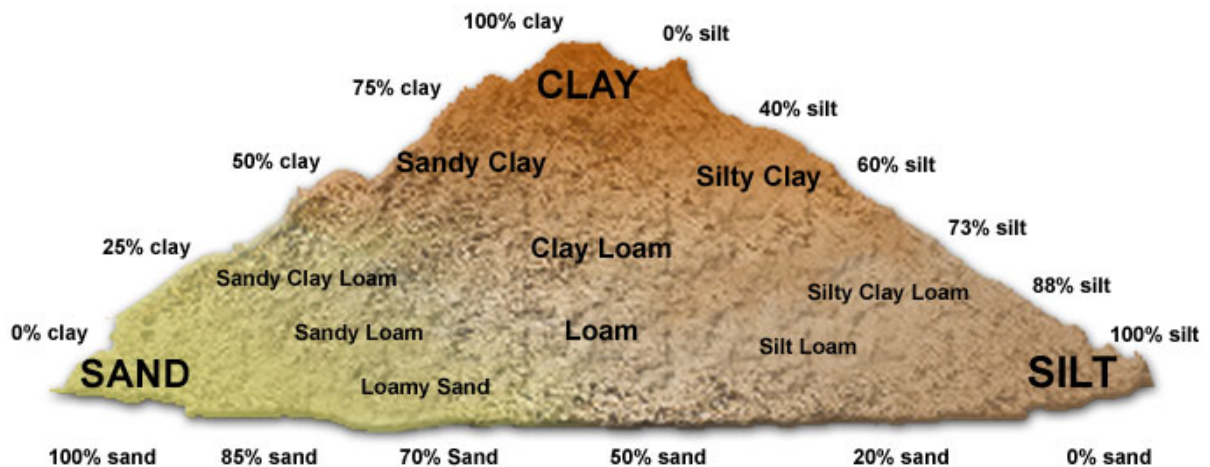
The existing drainage conditions for the subject property were determined from the available background documents, site visits and a topographic survey. Drainage from the site is described as follows:

The image below (Kuhlmann, Stacy 2017) shows the consistencies of soil types and how they compare to one another. The lower percentage of clay allows the soil to break up from the action of ploughing alone when not compacted or bound by extensive root masses.
