Schedule 'C' Municipal Class
Environmental Assessment

**County Road 22 (Horseshoe Valley Road)
Transportation Improvements
(From 3rd Line to 4th Line, Oro-Medonte)**

County of Simcoe

OCTOBER 2017

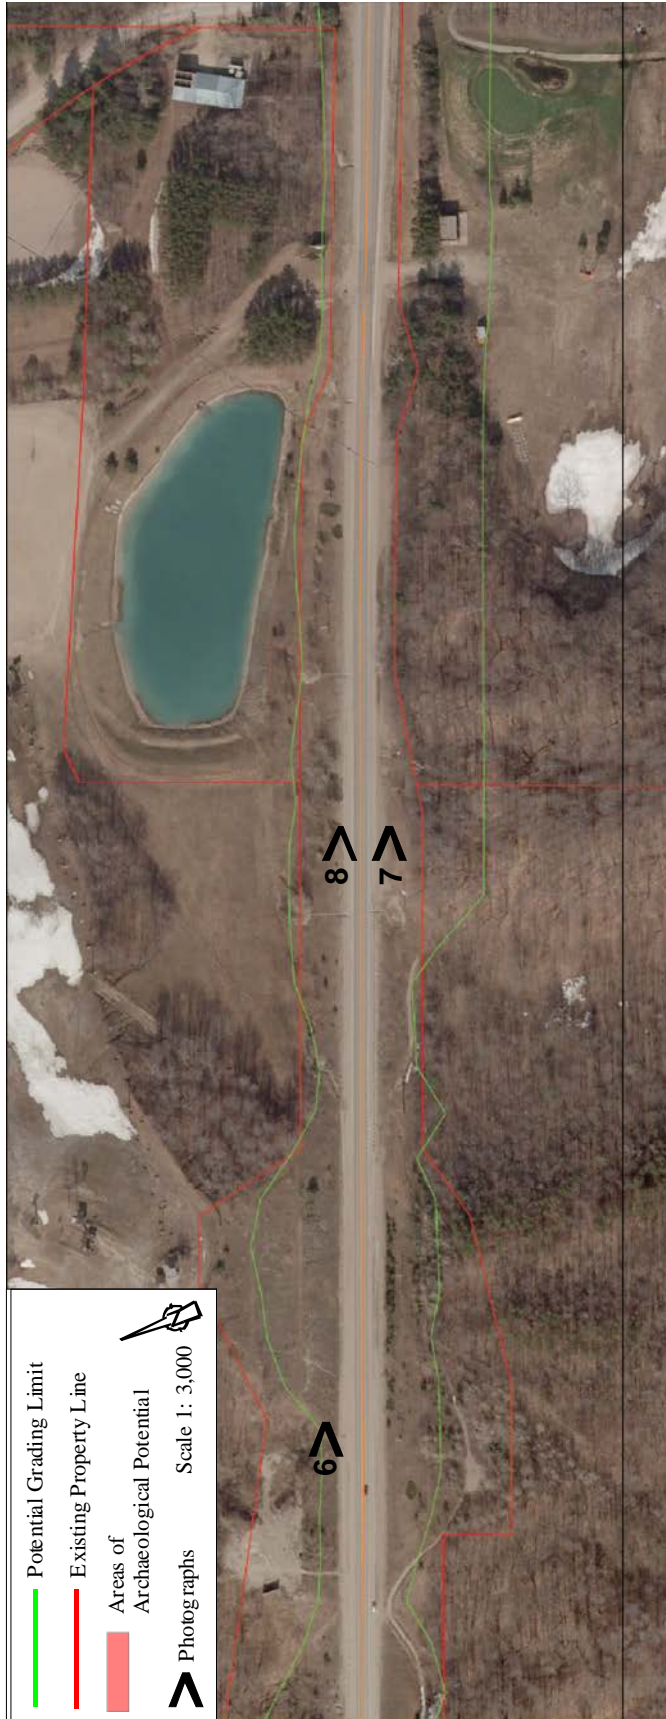
Figure 4. Archaeological Potential of the Western Section of the Road Corridor

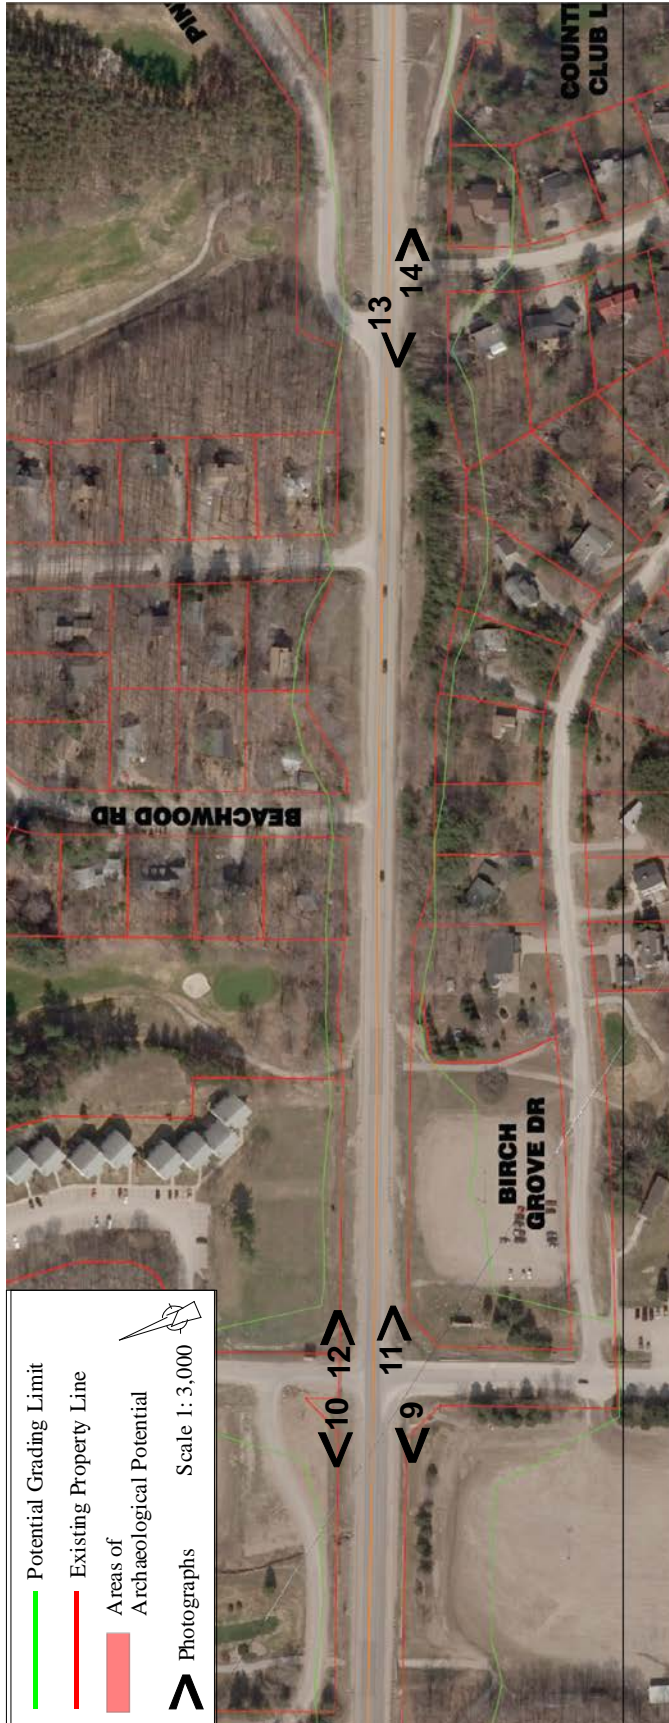
Figure 5. Archaeological Potential of the Central Section of the Road Corridor

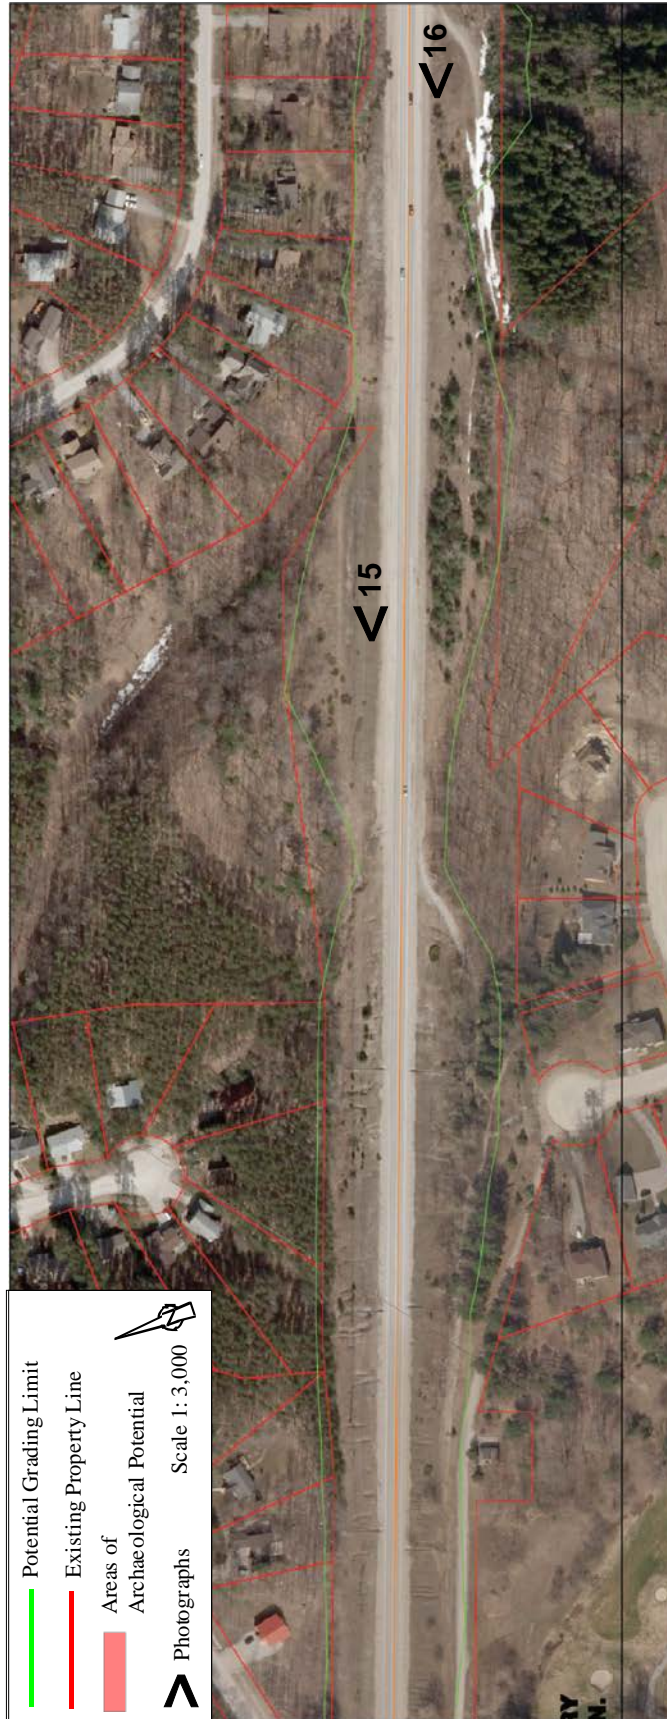
Figure 6. Archaeological Potential of the Eastern Section of the Road Corridor

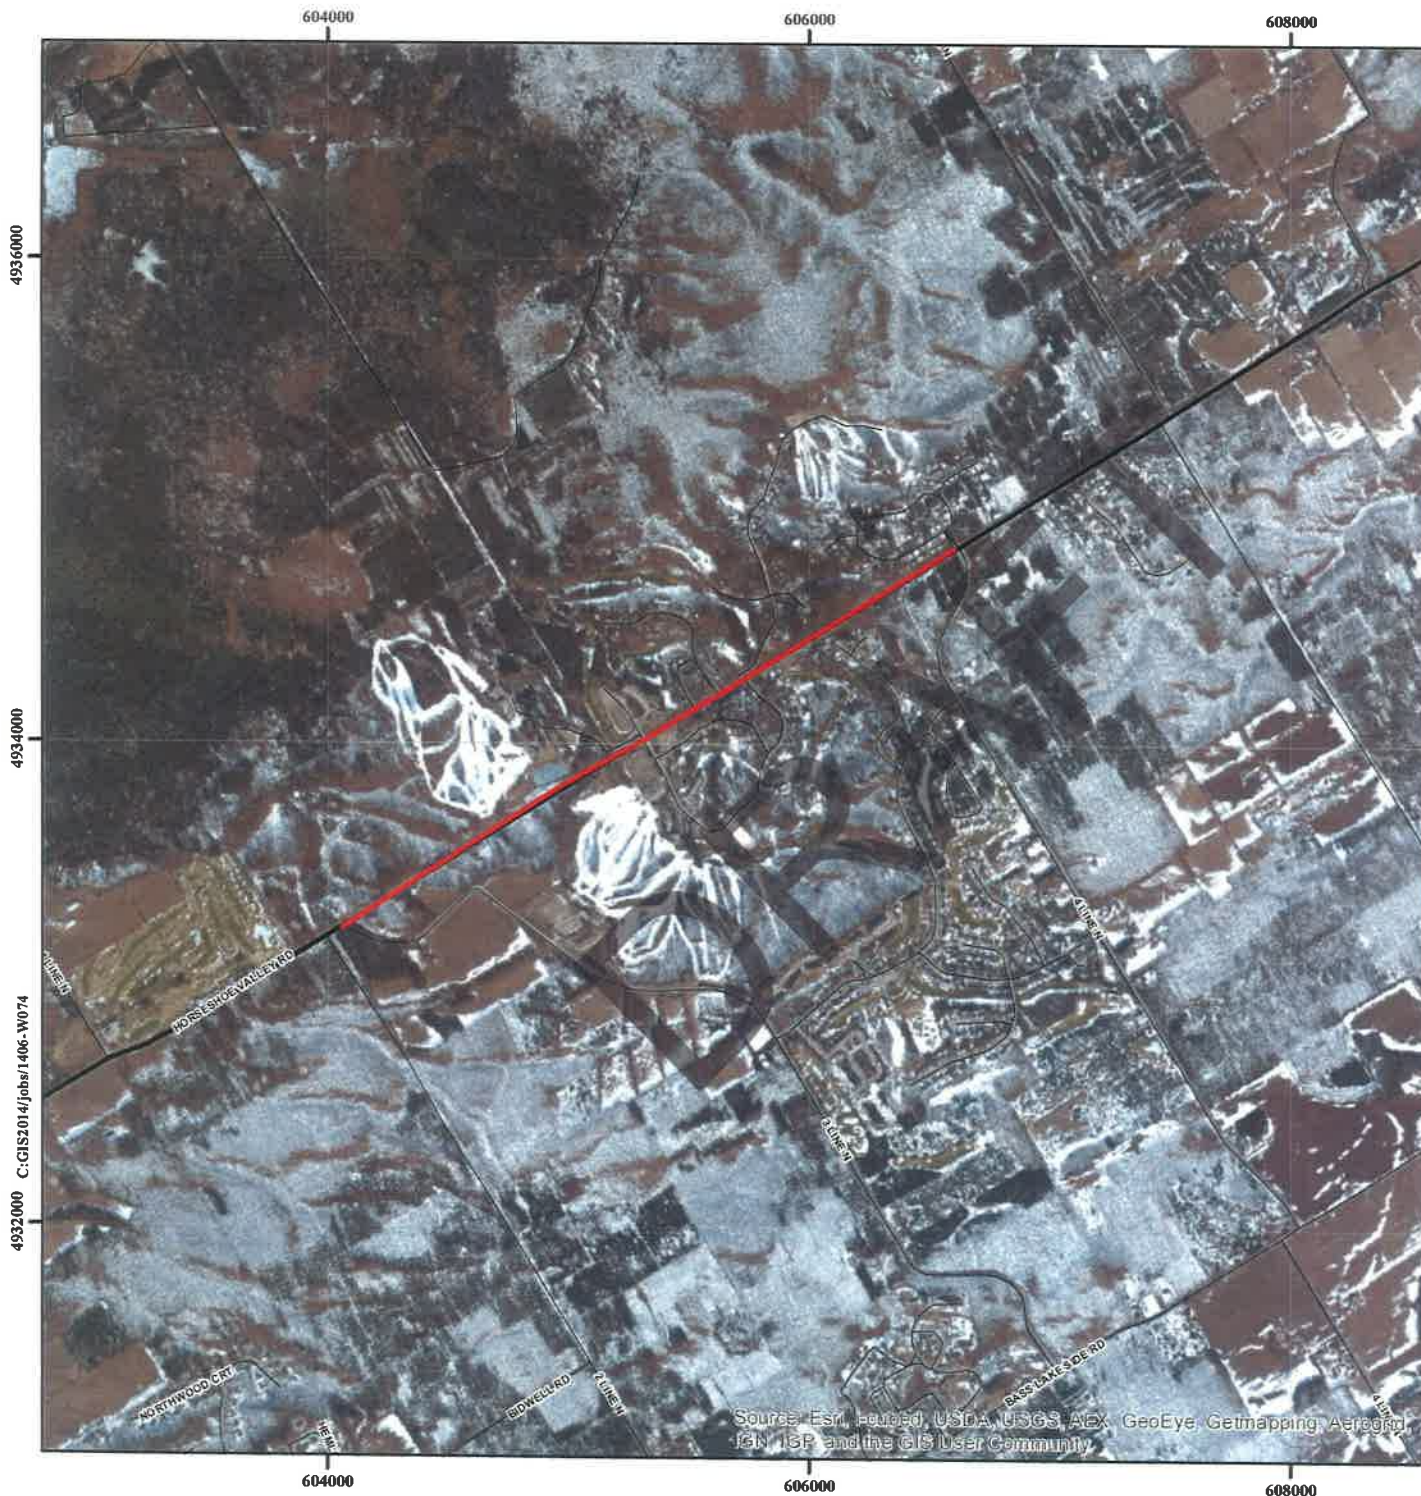
- Proposed Road Improvement
- Major Road
- Local Road

Title: Site Location Plan
Project: Proposed Road Improvement County Road 22 @ Birch Grove Drive and Between 3rd & 4th Lines County of Simcoe
Reference No. 1406-W074
Date: September 15, 2014
Scale:
Drawing No. 1

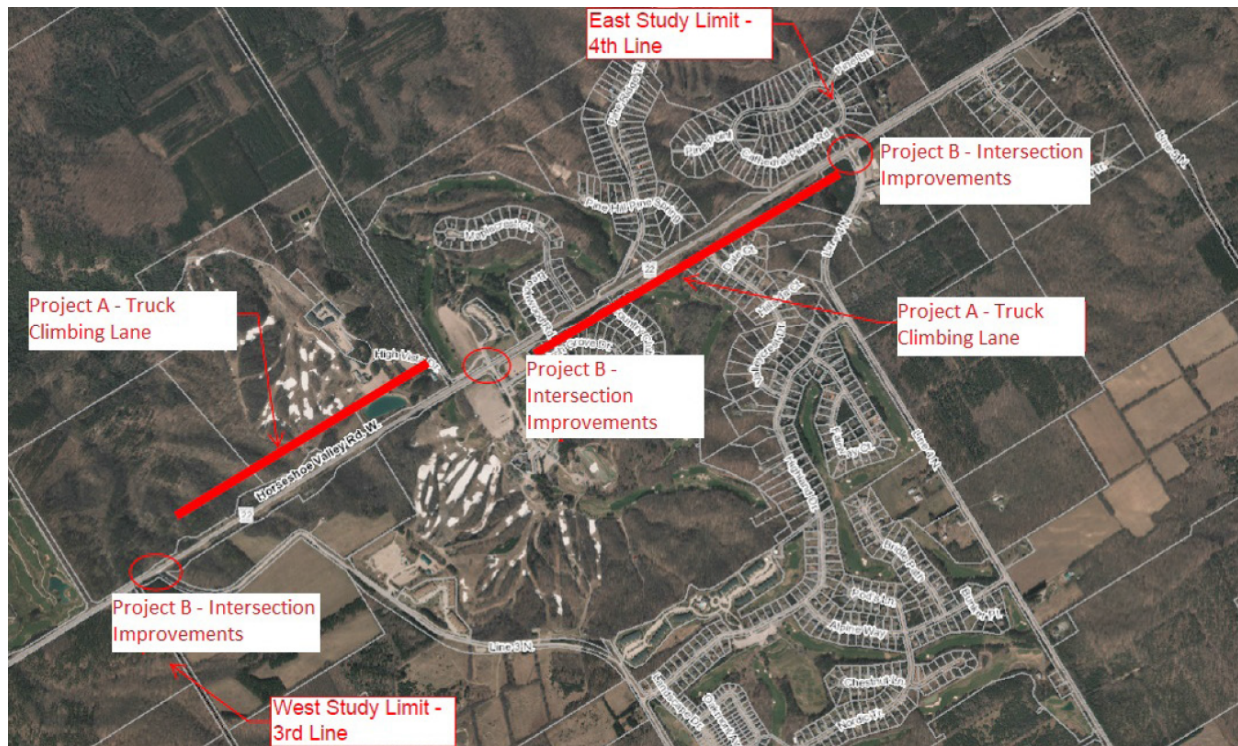
The EA comprises of two projects: Project A involved truck climbing lanes; and Project B involved intersection improvements. This study focuses on the intersection improvements component.

Figure 1-5: Two-part Scope of Environmental Assessment

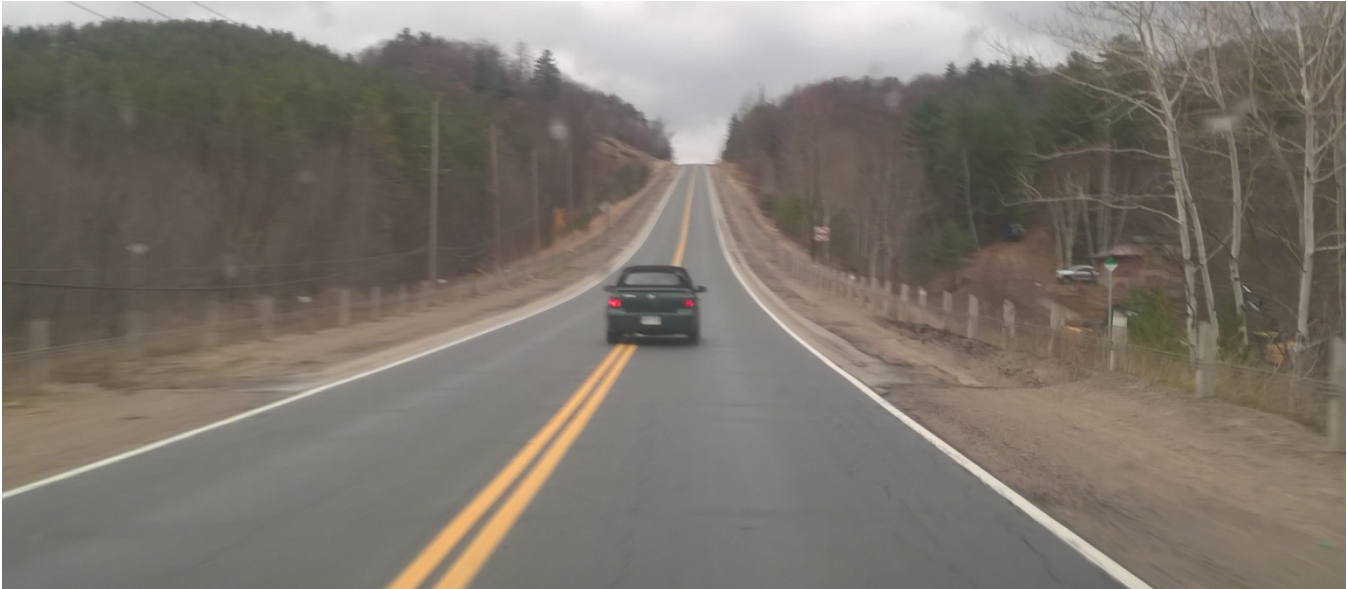
Figure 3-2: Illegal Passing Maneuver

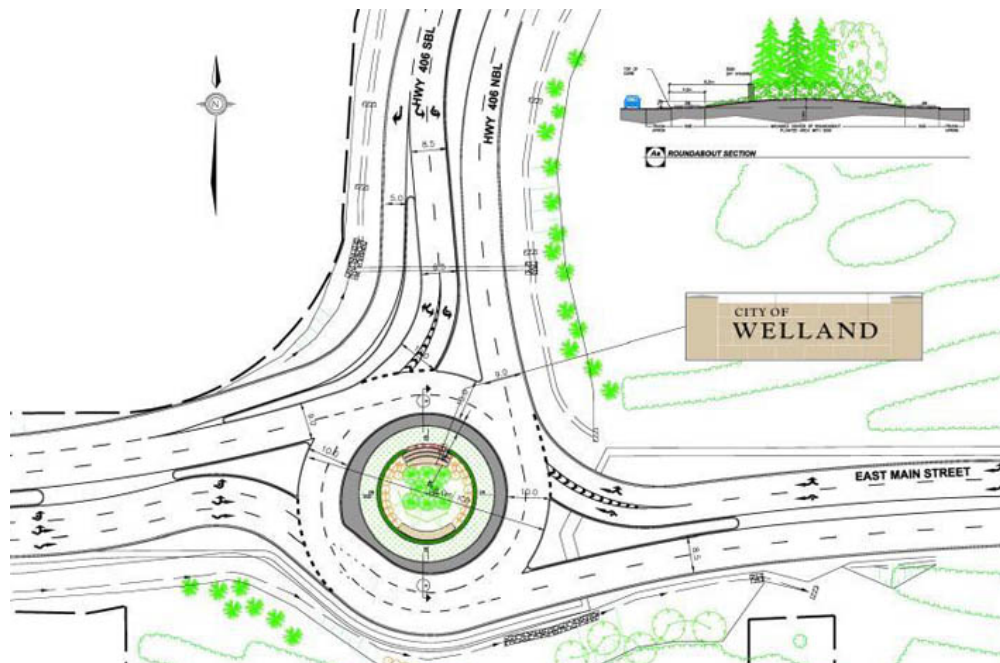
It is a relatively common practice to design roundabouts with a different number of entry lanes on different legs. For example, the Ministry of Transportation (MTO) constructed a roundabout at the end of Highway 406 in Welland with one three-lane entry, one two-lane entry with right-turn channelization, and one two-lane entry with no channelization, as illustrated in **Error! Reference source not found.** [16]. If truck climbing lanes are carried through the roundabouts, then the roundabouts would be called “partial multilane roundabouts” rather than “two-lane roundabouts”.

Figure 3-3: MTO Roundabout at Highway 406 and Main Street near Welland
