**April 13, 2018**

**FEASIBILITY STUDY**

**Simcoe Manor Campus Redevelopment**

**Simcoe County**

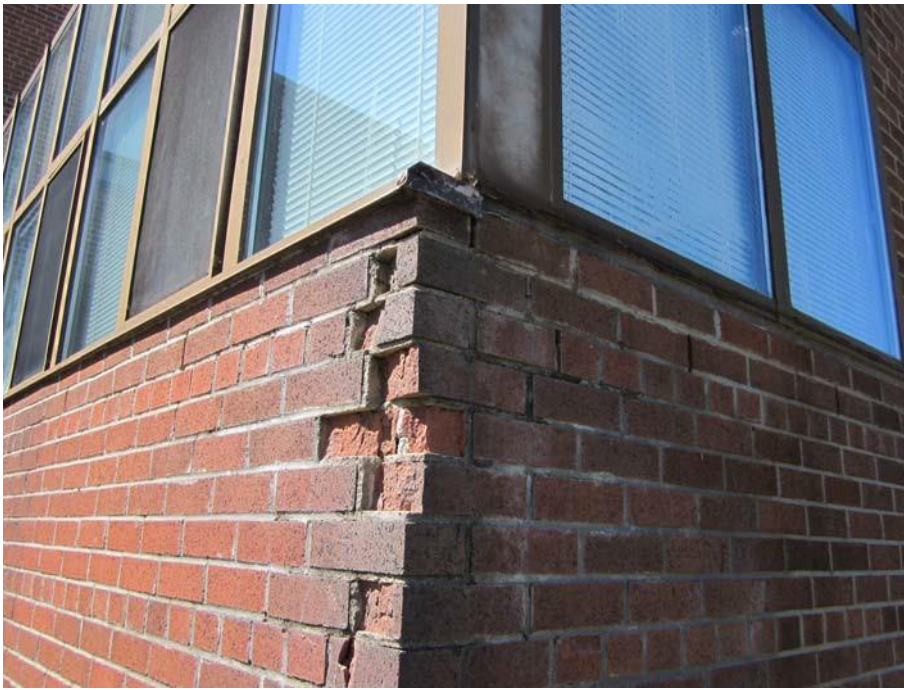
- The exterior of the building is showing signs of failure in its façade, canopies, terraces and windows which is compromising the integrity of the building envelope.
- On the façade of the building there is evidence of deteriorating brick cladding with the loss of mortar, partial bricks and in some instances multiple full bricks. This could be caused by water infiltrating the exterior walls from the outside of the building or from interior leaks. In some instances the failures are to a degree where full sections of brick should be removed and replaced before sections come away from the building.
- While reviewing different sections of exterior curtain wall it was found that multiple glazed units have failed and are showing condensation between the panes of glass. This means that the seals have failed

**Image 1: Building Envelope – Brick Cladding Failure**

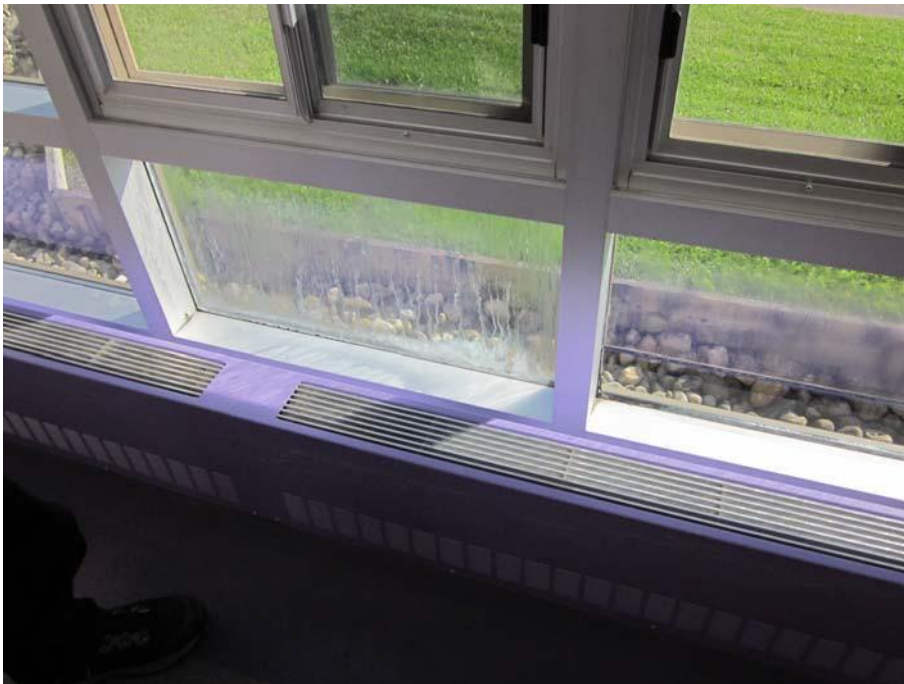
creating the loss of compressed gasses and all energy efficiency properties.

**Image 2: Building Envelope – Failed Glazing Unit**

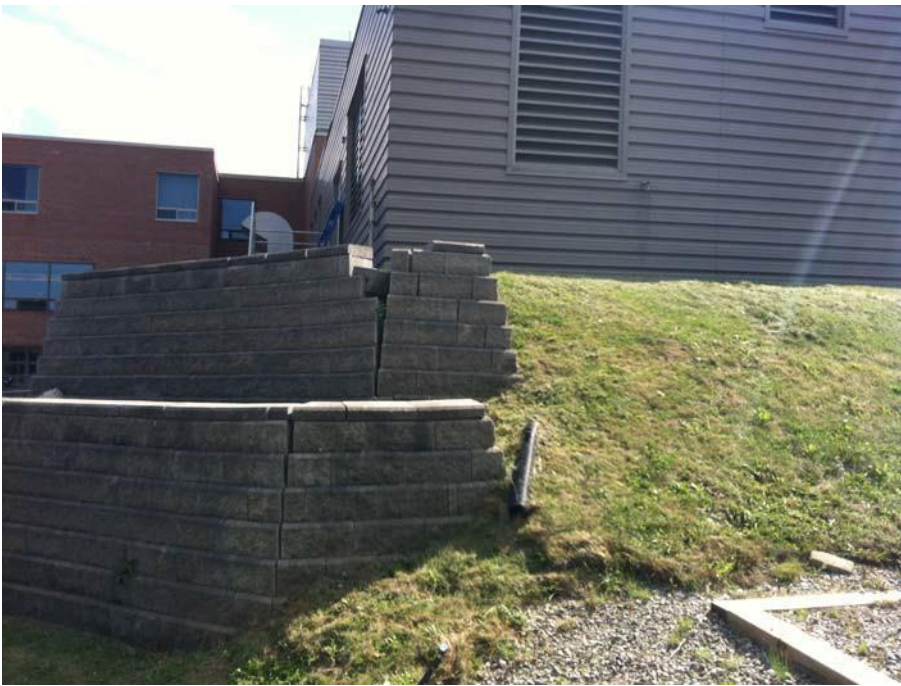
- Around the perimeter of the building in various instances there are retaining walls supporting landscaping and soil next to the building foundation. These retaining walls are showing their age with significant shifting, bowing and cracking.

**Image 3: Existing Site Condition – Failing Retaining Wall**

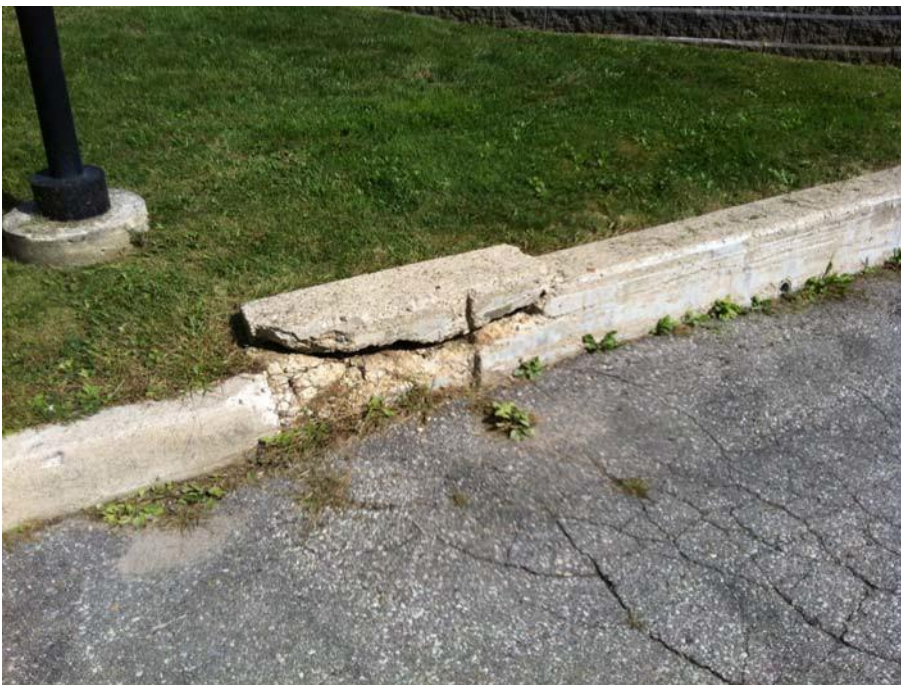
- The asphalt in the parking lots and drive aisles is broken in numerous spots compromising the site water control and are unsafe for pedestrian use in certain areas. It was also visually noticed that the grading in the parking lots on the north side of the property are graded to slope back towards the building in some instances and not towards catch basins. This promotes storm water runoff towards the foundation of the facility and is compromising the soil in those areas.

**Image 4: Existing Site Condition – Broken Asphalt Paving and Curb**

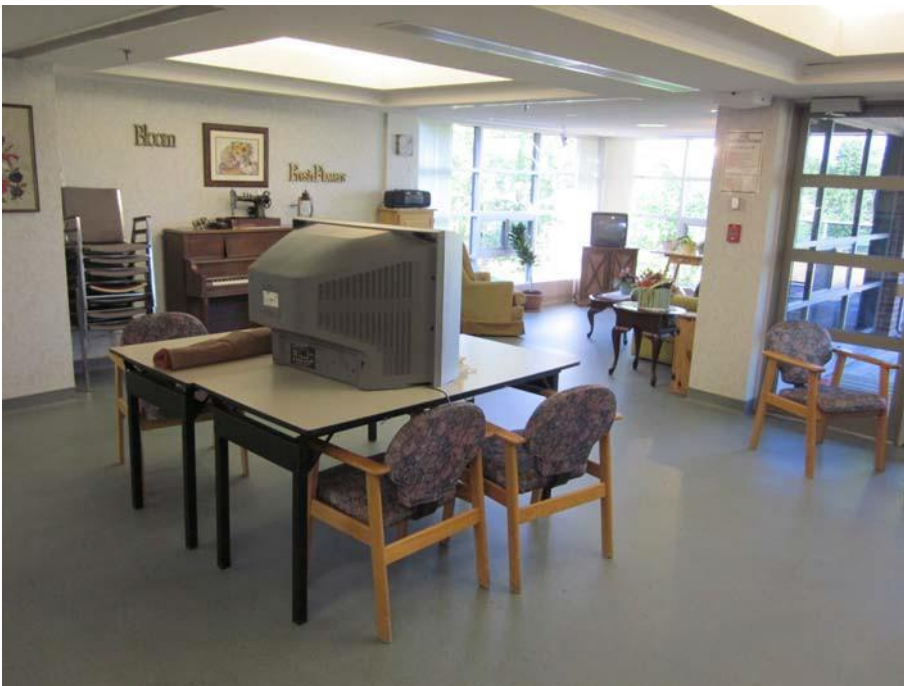
- The interior of the building while kept clean and in average condition does not support the resident's quality of life as best it can do to the limitations of the existing spaces. The finishes and fixtures are dated and are in need of a revitalization and renovation program so that the interior space would feel more modern and inviting.

Image 5: Interior Conditions – Existing Lounge

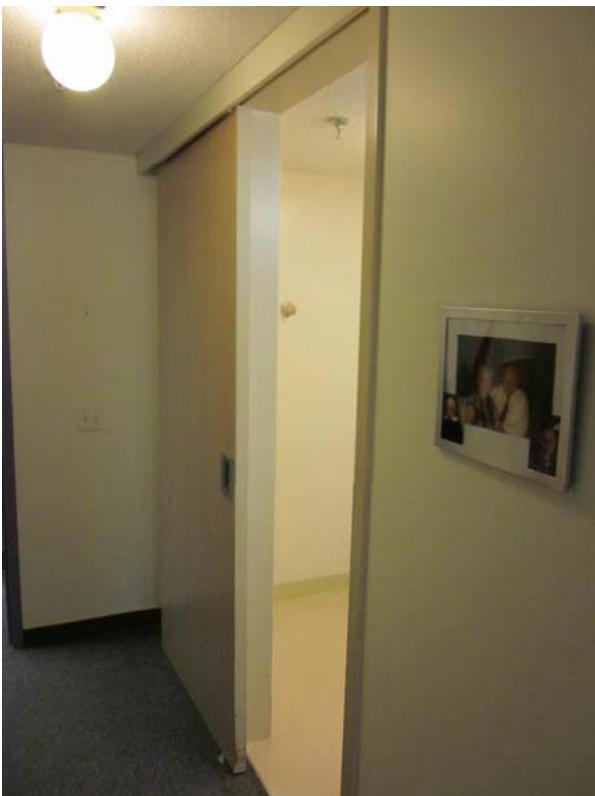
Image 6: Interior Conditions – Dated Suite

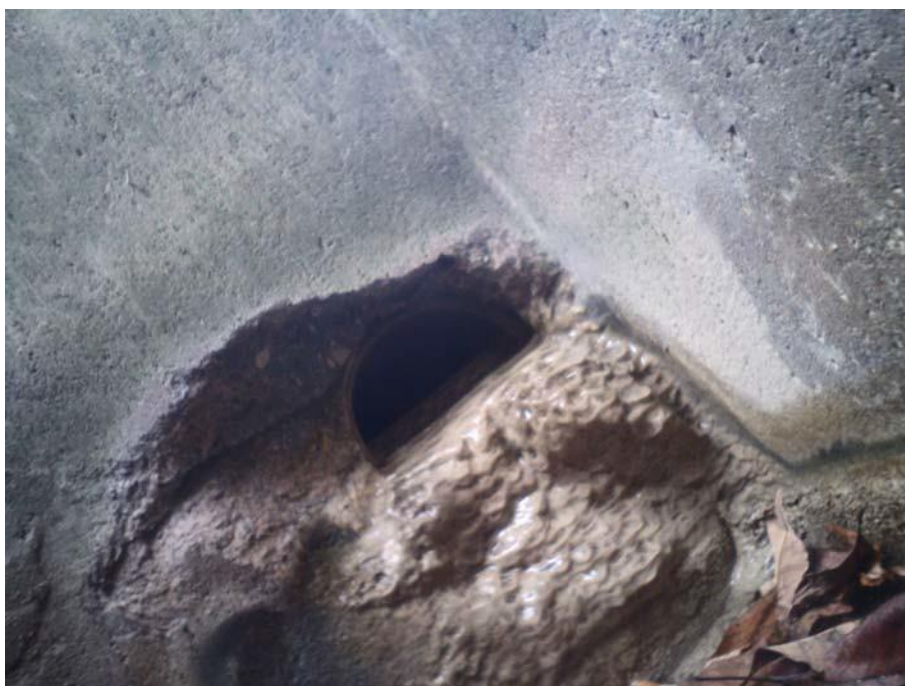
- The stormwater management infrastructure system on site is experiencing water flow limitations. This is due to drain lines becoming clogged. The clogging is a result of continual build of calcified deposits that are not able to be mechanically removed. This has limited the drains to not be large enough to accommodate rainfall events of today and have caused building flooding in 2017.
- Facility staff currently is required to use their resources to pump water from the building onto parking lot surfaces and to nearby catch. This is a facility issue that can be dealt with temporary solutions in the warm months of the year but is not feasible during winter months with below zero temperatures.

**Image 7: Site Conditions Calcified Drain Lines**

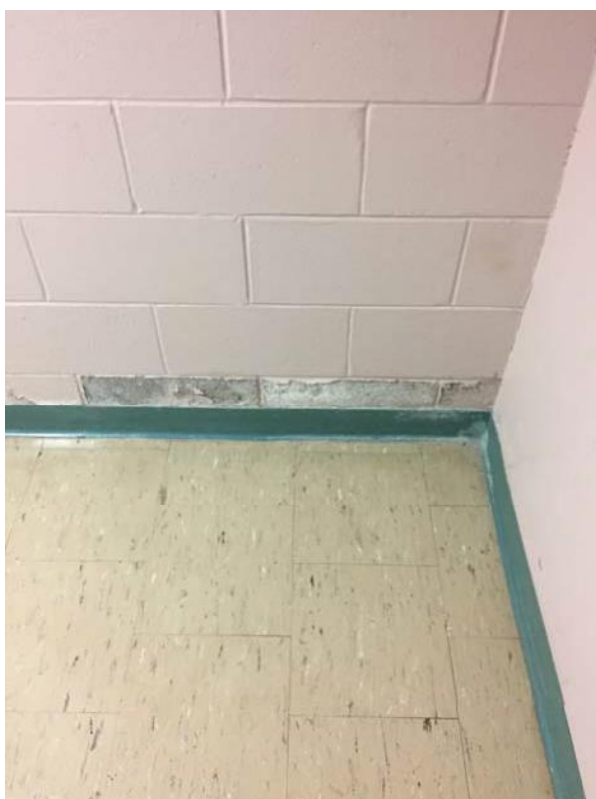
- While reviewing the facility it was shown to Salter Pilon how the ground water condition is affecting the lower Levels of the facility with flooding and water leeching. In Sump Pit locations the ground water can be seen at less than a meter below the lowest finish floor elevations. This condition provides high air moisture content that is creating paint to peel and constant water in the structure and walls of the basement and crawl space areas.

**Image 8: Interior Conditions – Water Damage**

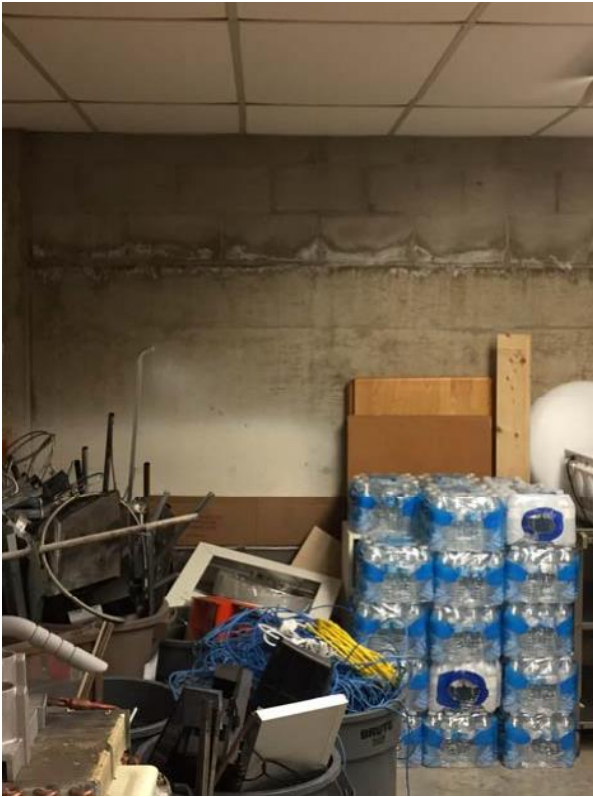
**Image 9: Interior Conditions – Water Damage**
