TREE INVENTORY PLAN

SIMCOE COUNTY SERVICE CAMPUS - ORILLIA
2 BORLAND STREET EAST, ORILLIA, ON

TREE INVENTORY/PRESERVATION PLAN

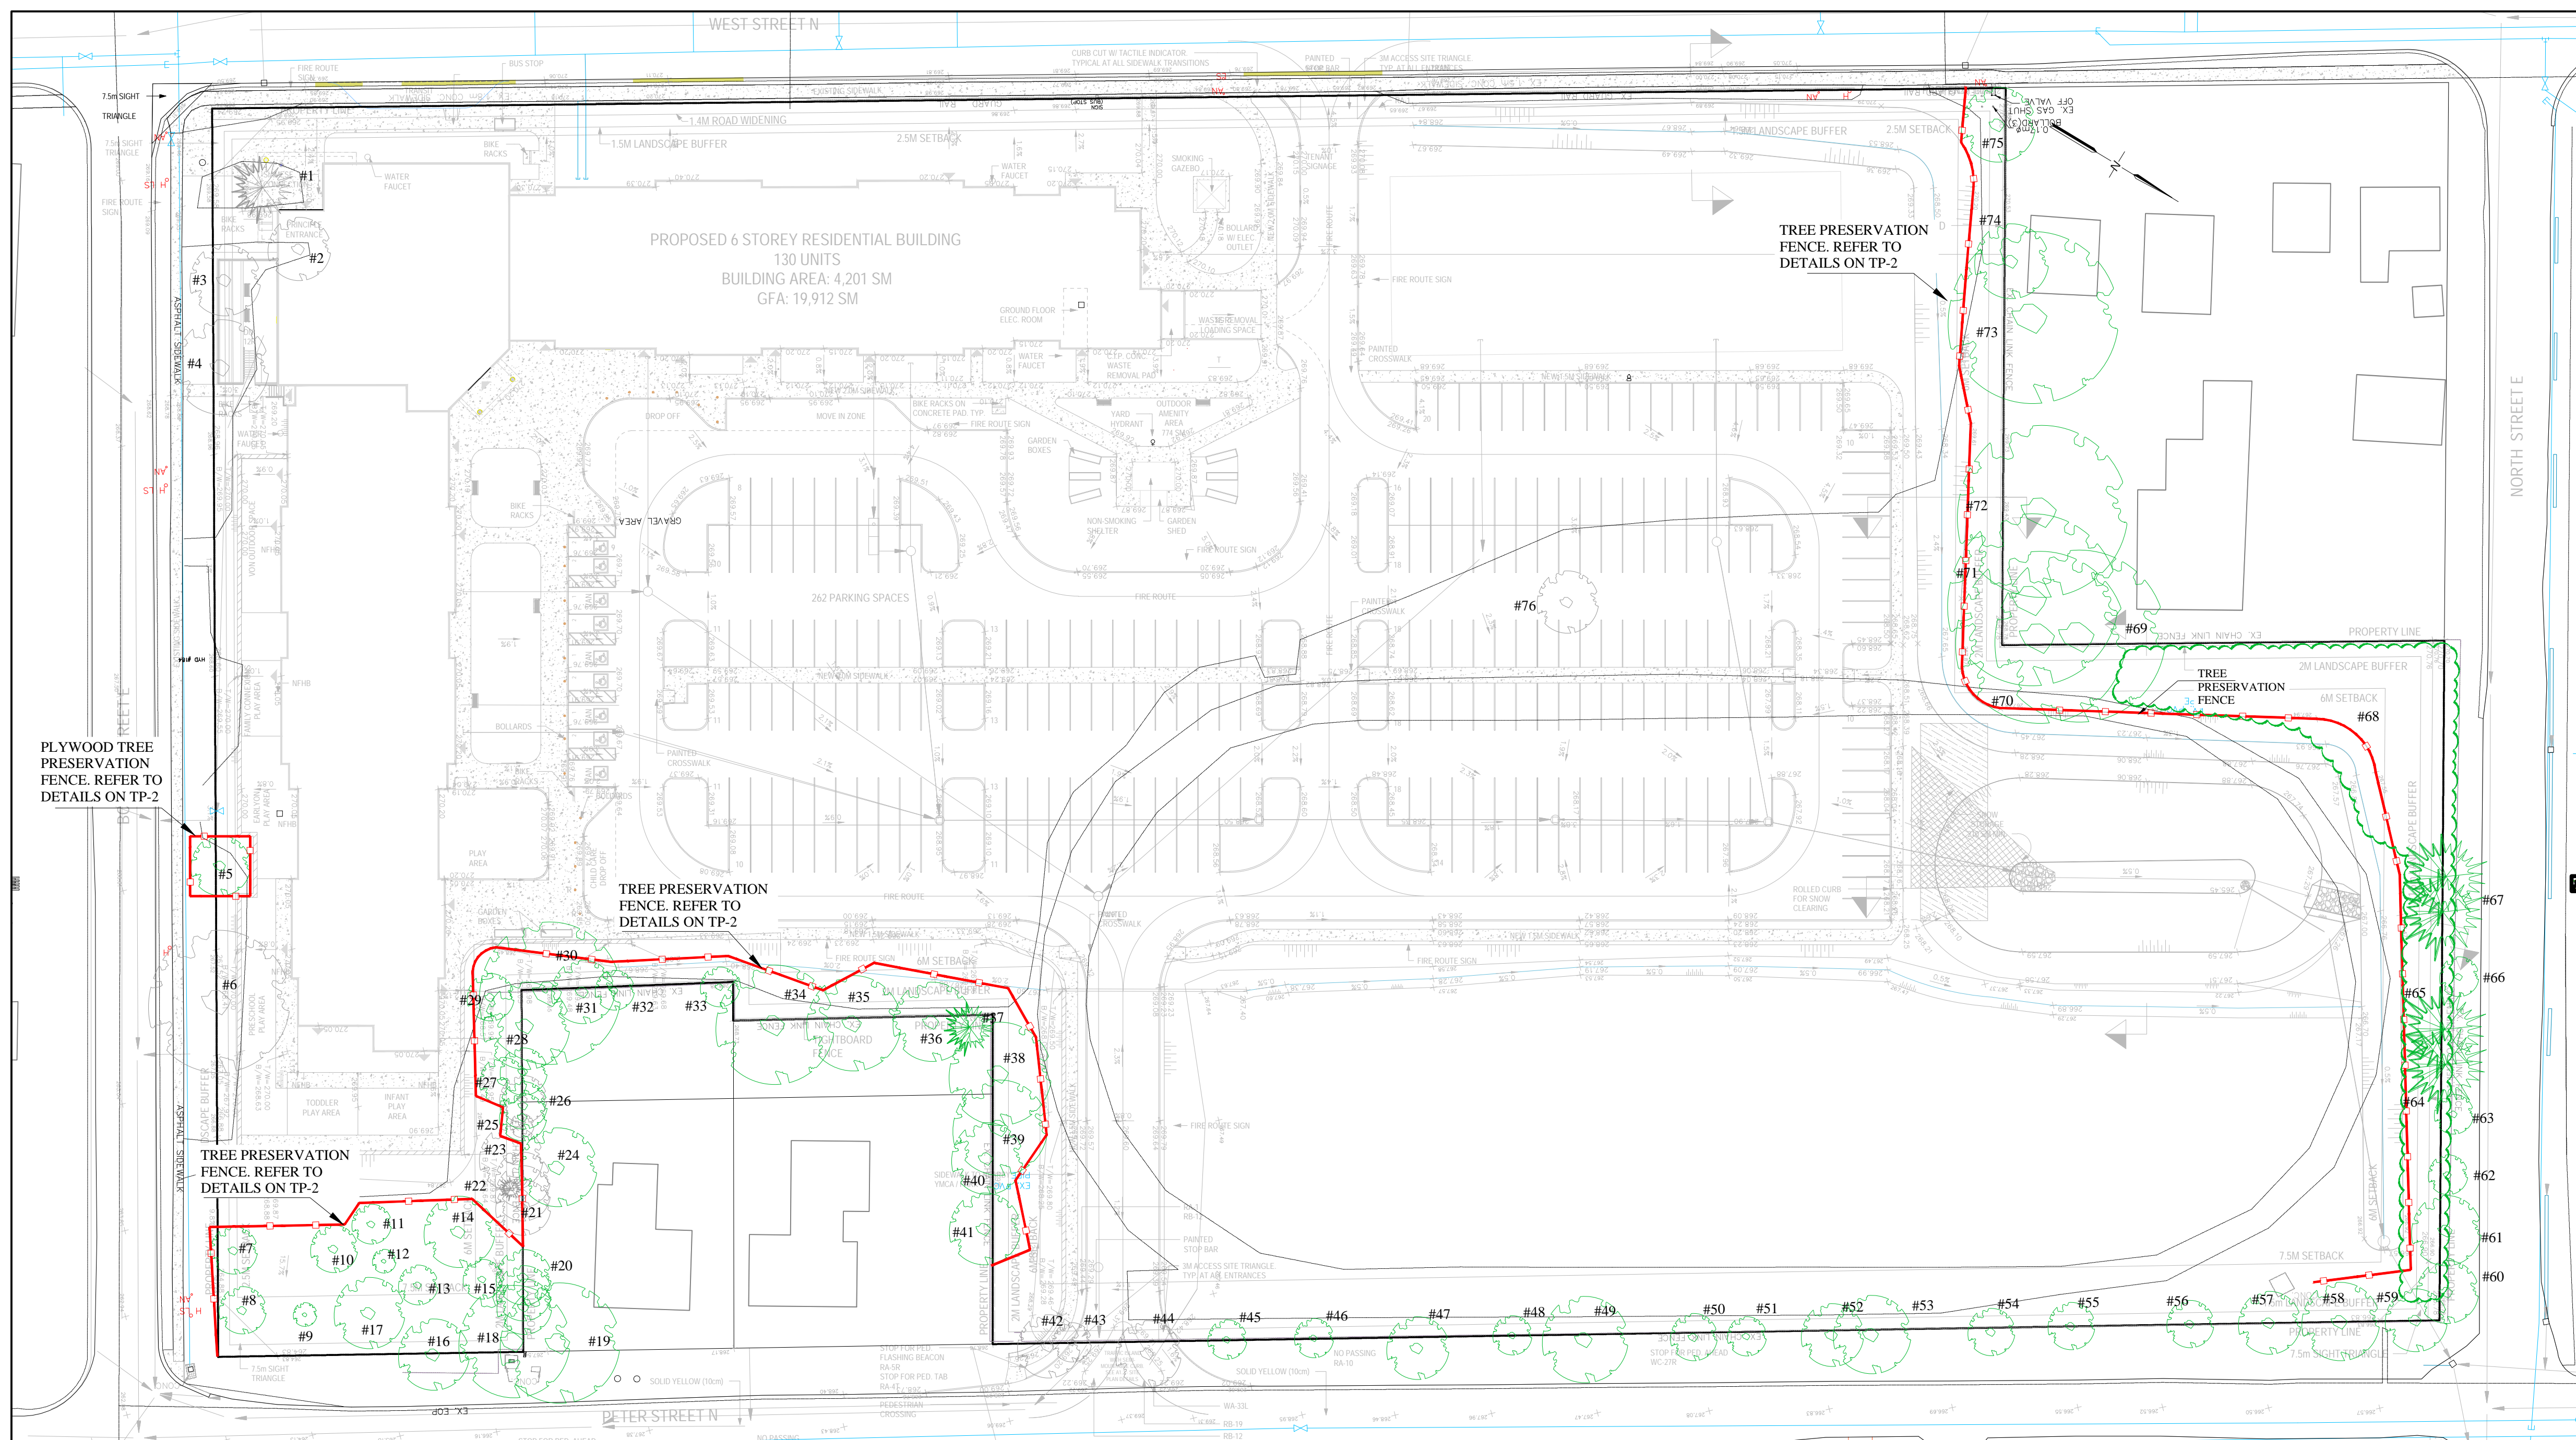
Tree #	No of trees	Botanical Name	Common name	DBH (cm)	Height (m)	Crown Ø (m)	Maturity	Health condition	Location	Preservation
1	1	<i>Pinus nigra</i>	Autian Pine	53	12	8	Mature	good	on site	removed
2	1	<i>Acer platanoides</i>	Norway Maple	38	10	8	Mature	good	on site	removed
3	1	<i>Quercus rubra</i>	Red Oak	36	12	9	Mature	good	on site	removed
4	1	<i>Acer saccharum</i>	Sugar maple	80	14	12	Mature	good	on site	removed
5	1	<i>Acer saccharum</i>	Sugar maple	30	12	7	Mature	good	remove animal nest	on site preserved
6	1	<i>Acer saccharum</i>	Sugar maple	85	14	18	Mature	good	on site	removed
7	1	<i>Acer platanoides</i>	Krismon King Norway Maple	25	12	6	Mature	fair-good	exposed roots	on site preserved
8	1	<i>Acer platanoides</i>	Krismon King Norway Maple	23	12	6	Mature	good	on site	preserved
9	1	<i>Acer rubrum</i>	Red Maple	9	5	3	Immature	good	on site	preserved
10	1	<i>Tilia americana</i>	Basswood	33	8	6	Mature	fair	remove adjacent Manitoba Maple seedling	on site preserved

11	1	<i>Malus sp.</i>	Crab Apple	20	8	5	Mature	fair	prune opt corned shoots	on site preserved
12	1	<i>Ambrosia arbores</i>	Servicetree	5	4	2	Immature	good	on site	preserved
13	1	<i>Acer platanoides</i>	Krismon King Norway Maple	14	7	5	Immature	fair	back back injuries	on site preserved
14	1	<i>Tilia americana</i>	Basswood	44	14	9	Mature	good	on site	preserved
15	1	<i>Acer platanoides</i>	Norway Maple	13	10	5	Immature	good	on site	preserved
16	1	<i>Acer platanoides</i>	Krismon King Norway Maple	35	14	9	Mature	fair-poor	back back injuries	on site preserved
17	1	<i>Tilia americana</i>	Basswood	27	12	7	Mature	good	on site	preserved
18	1	<i>Acer saccharum</i>	Sugar maple	65	20	14	Mature	good	remove vines	on site preserved
19	1	<i>Acer saccharum</i>	Sugar maple	80	20	15	Mature	good	1.5m on adjacent land	preserved
20	2	<i>Prunus americana</i>	American Ash	16	12	7	Immature	fair	on fence line	preserved
21	1	<i>Ulmus americana</i>	American Elm	18	12	7	Immature	fair	on fence line	preserved

22	1	<i>Prunus americana</i>	American Ash	18, 16, 16	12	7	Immature	2 poor, 1 dead	vine	on fence line removed
23	1	<i>Ulmus americana</i>	American Elm	23	12	7	Mature	poor	vines	on fence line removed

22	1	<i>Pinus resinosa</i>	Red Pine	12	3	16	Immature	poor	vines	1.8m to fence	removed
23	1	<i>Morus alba</i>	White Mulberry	21	10	8	Mature	poor	vines	1.5m to fence	removed
24	1	<i>Acer saccharum</i>	Sugar maple	70	18	10	Mature	good	on site	1.5m on adjacent land	preserved
25	1	<i>Prunus americana</i>	American Ash	35	-	-	Mature	± dead	on fence line	removed	
26	4	<i>Acer platanoides</i>	Norway Maple	25	10	6	Mature	fair	on fence line	preserved	
27	1	<i>Acer platanoides</i>	Norway Maple	12	10	6	Immature	good	on fence line	preserved	
28	1	<i>Quercus alba</i>	White Oak	38	14	11	Mature	good	on fence line	preserved	
29	1	<i>Acer platanoides</i>	Norway Maple	3+9	8	6	Mature	fair	clump	on site	preserved
30	1	<i>Acer platanoides</i>	Norway Maple	70	16	18	Mature	good	on fence line	preserved	
31	1	<i>Acer saccharum</i>	Sugar maple	29	12	8	Mature	good	on fence line	preserved	
32	1	<i>Acer platanoides</i>	Norway Maple	-10	8	5	Immature	fair	on fence line	preserved

33	1	<i>Prunus americana</i>	American Ash	11	8	5	Immature	fair	on fence line	preserved	
34	1	<i>Acer saccharum</i>	Sugar maple	60	14	15	Mature	good	on fence line	preserved	
35	1	<i>Acer saccharum</i>	Sugar maple	70	12	15	Mature	fair	dead branches	on fence line	preserved
36	1	<i>Acer saccharum</i>	Sugar maple	60	12	15	Mature	fair	on fence line	preserved	
37	1	<i>Pinus strobus</i>	White Pine	37	8	7	Mature	fair	on fence line	preserved	
38	1	<i>Acer saccharum</i>	Sugar maple	60	12	13	Mature	good	on fence line	preserved	
39	1	<i>Acer saccharum</i>	Sugar maple	70	12	12	Mature	good	on fence line	preserved	
40	1	<i>Acer platanoides</i>	Norway Maple	30	12	9	Mature	good	on fence line	preserved	
41	1	<i>Acer platanoides</i>	Norway Maple	30	8	9	Mature	good	on fence line	preserved	
42	1	<i>Acer platanoides</i>	Norway Maple	20	10	8	Mature	fair	on fence line	removed	
43	1	<i>Acer saccharum</i>	Sugar maple	10	8	5	Immature	fair	on fence line	removed

44	1	<i>Acer platanoides</i>	Norway Maple	20	10	9	Mature	fair	on fence line	removed	
45	1	<i>Prunus americana</i>	American Ash	12	8	5	Immature	fair	clump	on fence line	removed
46	1	<i>Prunus americana</i>	American Ash	20	10	4	Mature	fair	clump	0.3m on adjacent land	preserved
47	1	<i>Acer saccharum</i>	Sugar maple	35	12	8	Mature	good	on fence line	preserved	
48	1	<i>Acer platanoides</i>	Norway Maple	10	7	5	Immature	fair	on fence line	preserved	
49	3	<i>Prunus americana</i>	American Ash	30, 20, 20	12	11	Mature	fair	clump	0.6m on adjacent land	preserved
50	1	<i>Acer saccharum</i>	Sugar maple	10	10	6	Immature	fair	on fence line	preserved	
51	1	<i>Prunus americana</i>	American Ash	13	10	5	Immature	fair-poor	on fence line	preserved	
52	1	<i>Prunus americana</i>	American Ash	15-15	10	8	Immature	fair	forked at base	on fence line	preserved
53	1	<i>Acer saccharum</i>	Sugar maple	10	10	6	Immature	fair	on fence line	preserved

54	3	<i>Prunus americana</i>	American Ash	12	12	6	Immature	fair	on fence line	preserved	
55	1	<i>Prunus americana</i>	American Ash	24	10	7	Mature	poor	on fence line	preserved	
56	1	<i>Prunus americana</i>	American Ash	20	12	6	Mature	poor	vines	0.5m on adjacent land	preserved
56	1	<i>Juglans nigra</i>	Black Walnut	22	12	6	Mature	poor	vines	on fence line	preserved
57	1	<i>Acer saccharum</i>	Sugar maple	25	12	8	Mature	fair	on fence line	preserved	
58	1	<i>Acer platanoides</i>	Norway Maple	30	12	10	Mature	fair	on fence line	preserved	
59-60	1	<i>Acer negundo</i>	Manitoba Maple	7+15	12	8	Immature	poor	on site	preserved	
61	group	<i>Acer platanoides</i>	Norway Maple	15	10	9	Immature	fair	on site	preserved	
62	1	<i>Acer platanoides</i>	Norway Maple	27	8	5	Mature	fair	on fence line	preserved	
63	1	<i>Acer negundo</i>	Manitoba Maple	22	10	12	Mature	poor	on site	preserved	
64	1	<i>Pinus resinosa</i>	Red Pine	42	12	12	Mature	fair	1.2m to fence	preserved

65	1	<i>Pinus resinosa</i>	Red Pine	42	12	12	Mature	fair	1.2m to fence	preserved	
66	1	<i>Acer platanoides</i>	Norway Maple	27	8	5	Mature	fair	on fence line	preserved	
67	4	<i>Pinus strobus</i>	White Pine	28, 20, 27, 30	12	12	Mature	fair	1.2m to fence	preserved	
68	group	<i>Acer platanoides</i>	Norway Maple	-10	12	12	Immature	fair	on site	preserved	
69	1	<i>Quercus rubra</i>	Red Oak	50	18	20	Mature	good	1.2m on adjacent land	preserved	
70	1	<i>Acer saccharum</i>	Sugar maple	50	18	20	Mature	good	0.7m on adjacent land	preserved	
71	1	<i>Acer saccharum</i>	Sugar maple	18	10	6	Immature	good	1.2m on adjacent land	preserved	
72	1	<i>Acer saccharum</i>	Sugar maple	70	12	12	Mature	good	3.5m on adjacent land	preserved	
73	1	<i>Acer saccharum</i>	Sugar maple	70	12	19	Mature	good	2.5m on adjacent land	preserved	
74	1	<i>Juglans nigra</i>	Black Walnut	25	12	9	Mature	fair	0.2m on adjacent land	preserved	
75	1	<i>Acer negundo</i>	Manitoba Maple	18	10	9	Immature	poor	on site	preserved

76	1	<i>Acer saccharum</i>	Sugar maple	40	12	8	Mature	fair	on site	removed
